# REPORT OF BOREHOLE: BH243

PROJECT: Gold Coast Rapid Transit SURFACE RL: 15.56 m DATUM: AHD

## REPORT OF CORE PHOTOGRAPHS: BH243

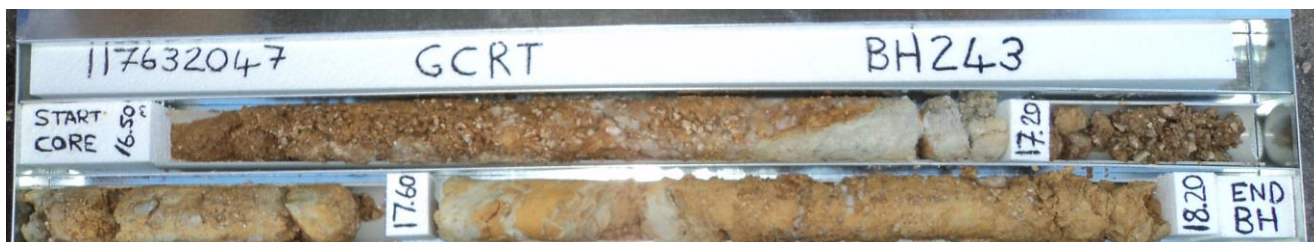
**16.50 – 18.20 m**

| Drilling | | | | | | Field Material Description | | | | Defect Information | | | |
|---|---|---|---|---|---|---|---|---|---|---|--|---|--|
| | | | 100 | 0 | | | ARGILLACEOUS SILTSTONE | EW | | | | 1000 | |
| | | | | | | | fine grained, orange brown and pale grey, non | | | | | 3000 | |
| | | | | | | | intact, recovered as sandy silt; fine to coarse | | | | | | |
| | | | 92 | 0 | | | thinly to thickly laminated (1-20 mm) with siliceous | | | | | | |
| | | | | -1.64 | | | bands / beds (6-50 mm) | | | | | | |
