# BOREHOLE ENGINEERING LOG

HOLE NO : N071B\_BH04

CLIENT : TRANSPORT AND MAIN ROADS	POSITION : E: 358648, N: 8137295 (56 MGA94)	PAGE : 1 OF 3
PROJECT : TNRP	SURFACE ELEVATION : 337.0 (AHD)	DATE DRILLED : 7/22/13 TO 7/22/13
JOB NO : CB27000.F687	DIP / AZIMUTH : 90°	LOGGED BY : JP
LOCATION : KENNEDY HWY (CAIRNS - MAREEBA)	CHECKED BY : AJ

Client: Transport and Main Roads	
		Project: Transport Network Reconstruction Program	
drawn	AJ	Core Photograph – N071B_BH04	
date	7/11/2013	Project no. CB27000	
scale	NTS	Photo No: N071B_BH04 1 of 1

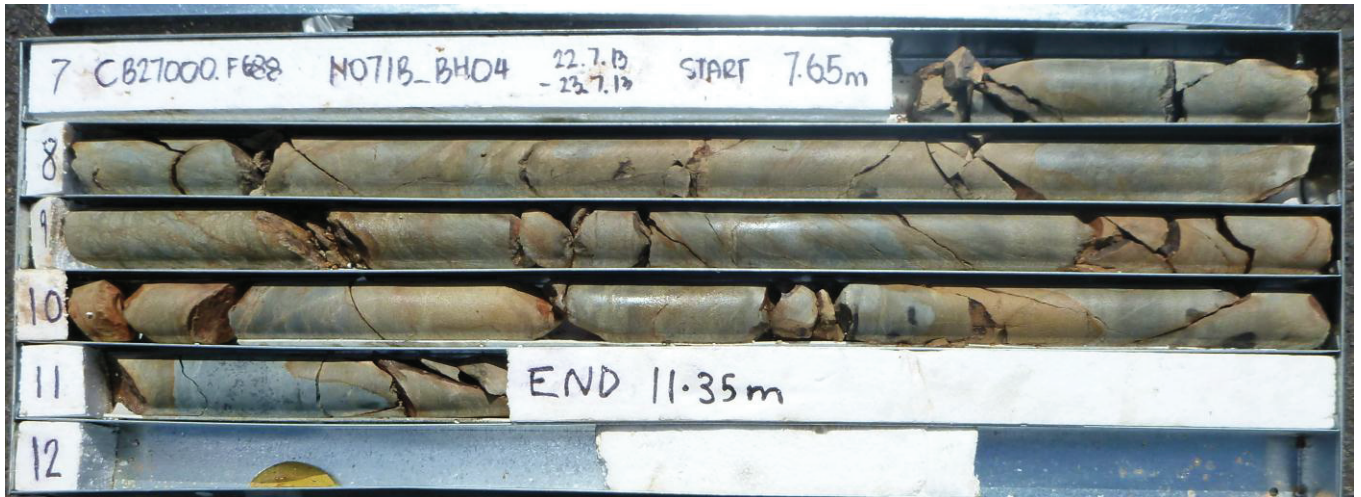
334.0	6.0							
			330.0	7.0							
						START CORING AT 7.65m					
		100% TCR 29% RQD 8.00	329.0	8.0		QUARTZITE: Grey, green grey, orange brown, indistinct to distinct foliations 40° to 60°	MW			JT 80° IR RF JT 70° IR VR Fe JT 70° IR VR Fe JT 50° UN VR Fe JT 60° UN VR Fe JT 80° UN VR Fe JT 60° UN VR Fe CZ 40° UN VR Fe JT 60° PR RF Fe JT 90° PR RF JT 50° PR RF CZ 60° UN VR JT 40° PR RF JT 40° UN RF CZ 20° IR VR JT 80° UN RF JT 60° IR VR JT 40° PR RF Fe JT 50° PR RF JT 60° PR RF JT 60° PR RF JT 90° IR RF JT 70° UN RF CZ 70° ST - IR, VR, 50 mm JT 80° ST VR Fe JT 80° IR RF Fe JT 40° IR VR JT 60° UN VR JT 30° IR VR JT 90° UN VR JT 80° UN VR JT 60° IR RF JT 30° PR S JT 80° PR RF JT 60° PR RF JT 30° PR RF JT 60° CU RF JT 60° IR RF Fe JT 60° PR RF Fe JT 60° IR VR Fe JT 60° VR Fe JT 90° IR VR JT 60° CU RF JT 50° PR RF JT 60° IR RF Fe JT 10° PR RF Fe JT 30° IR RF Fe JT 70° IR RF Fe JT 80° IR RF Fe JT 80° IR RF Fe JT 70° PR S Fe JT 70° IR RF Fe JT 30° IR RF JT 80° IR RF Fe JT 90° PR S Fe JT 60° PR S Fe JT 80° IR RF Fe

100% TCR 51% RQD 8.95	328.0	9.0							
		100% TCR 42% RQD 9.90	327.0	10.0							
		100% TCR 0% RQD 10.10									
		100% TCR 41% RQD 11.35	326.0	11.0

11.35m			End of Borehole					
			325.0	12.0
