# ENGINEERING BOREHOLE LOG

BOREHOLE No **BH137**  
SHEET **1** of **4**  
REFERENCE No **12082**

PROJECT Mackay Ring Road Geotechnical Investigation - Stage 1  
LOCATION Fursden Creek Bridge Abutment A; CH: 9056m; COORDINATES 721483.8 E; 7661372.2 N  
PROJECT No FG6184 SURFACE R.L. 7.63m PLUNGE \_\_\_\_\_ DATE STARTED 3/11/14 GRID DATUM GDA 94 /MGA Zone 55  
JOB No \_\_\_\_\_ HEIGHT DATUM AHD BEARING \_\_\_\_\_ DATE COMPLETED 4/11/14 DRILLER Saxon Drilling

# CORE PHOTO LOG

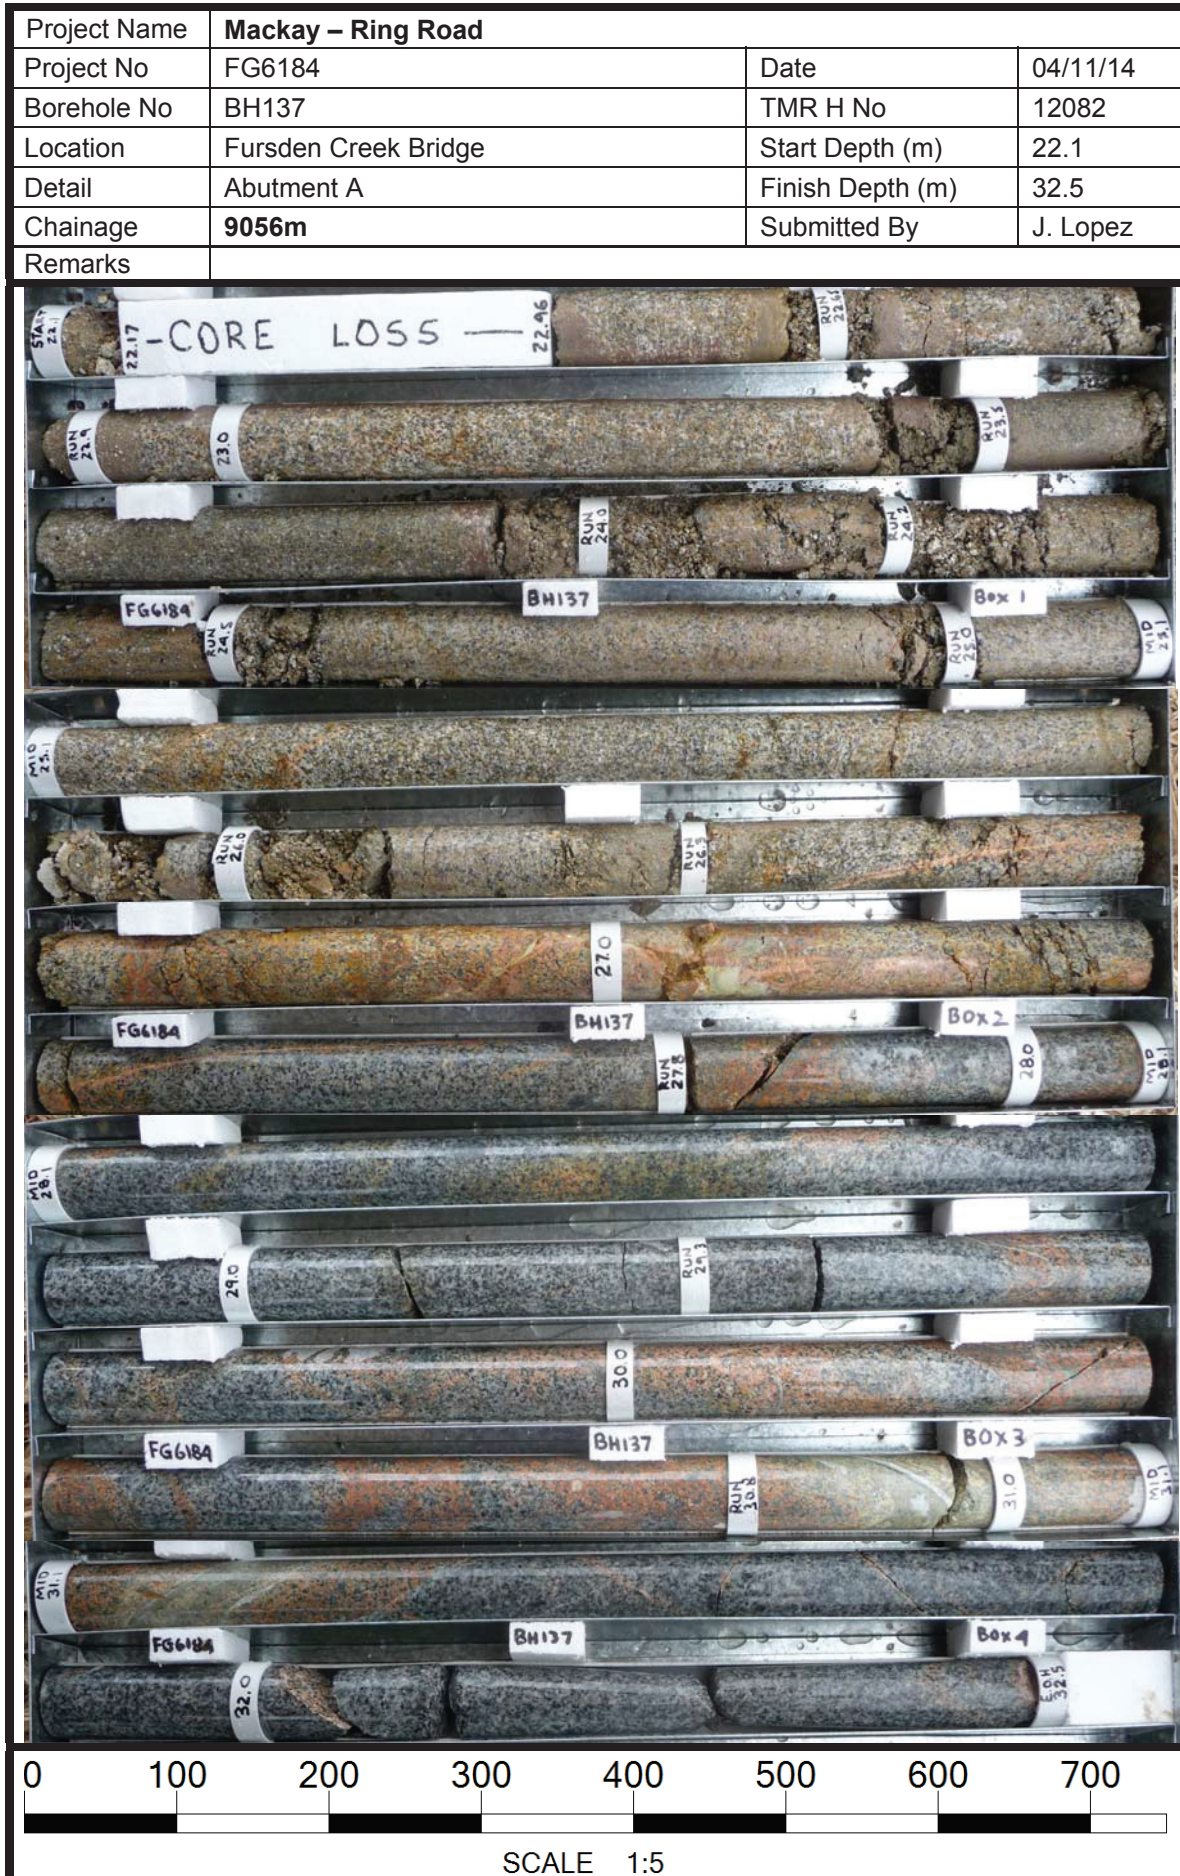
DEPTH (m)	R.L. (m)	AUGER CASING WASH BORING CORE DRILLING	RQD ( ) %	CORE REC %	SAMPLE	MATERIAL DESCRIPTION	LITHOLOGY	USC WEATHERING	INTACT STRENGTH	DEFECT SPACING (mm)	GRAPHIC LOG	ADDITIONAL DATA AND TEST RESULTS	SAMPLES TESTS
20	-12.37				V	<b>GRANODIORITE (Kgwu)</b> <b>XW: (Cont'd)</b>	+					30/100	SPT
21					W		+	XW				30/60	SPT
22					X		+					30/90	SPT
23	-15.31		(0)		X	<b>GRANODIORITE (Kgwu)</b> <b>HW:</b> Brown, grey and white, fine to coarse grained, massive, mainly very low strength. Defects: - Js; 15°-30° (2/m); PI/Ro, TI-CD: - Js; 75°-85° (1/m); PI/Ro, TI-CD:	+	HW				23.43m-23.50m: BZ; DI?	q <sub>u</sub> =93kPa; UCS
24			47				+	XW					
25			(0)				+						
26			100				+	HW				25.85m-26.10m: BZ; DI?	
27	-19.74		(84)				+						
28			100			<b>GRANODIORITE (Kgwu)</b> <b>SW:</b> Grey to pale grey and pink, fine to coarse grained, massive, very high strength. Defects: - Js; 10°-30° (1/m); PI/Ro, TI, Cn; - Js; 40°-60° (1/m); PI/Ro, TI, Cn;	+	SW				Is(50) = 7.01MPa Is(50) = 5.49MPa UCS=96.4MPa	D (27.94m) A (27.98m)

29			(0)				+					Is(50) = 8.61MPa Is(50) = 12.84MPa	A (28.85m) D (28.90m)
30			100				+					Is(50) = 6.32MPa; # Is(50) = 8.81MPa	A (29.52m) D (29.58m)

DEPTH (m)	R.L. (m)	AUGER CASING WASH BORING CORE DRILLING	RQD ( ) %	SAMPLE	MATERIAL DESCRIPTION	LITHOLOGY	USC	WEATHERING	INTACT STRENGTH	DEFECT SPACING (mm)	GRAPHIC LOG	ADDITIONAL DATA AND TEST RESULTS	SAMPLES TESTS
30	-22.37												
31			100 (80)		GRANODIORITE (Kgwu) SW: (Cont'd)			SW					
32												Is(50) = 8.45MPa Is(50) = 9.51MPa	D (31.87m) A (31.92m)
32.50	-24.87		100										
33					Borehole terminated at 32.5m. .								
34													
35													
36													
37													
38													
39													
40
