Project: Velway (V1), Section E: Birdwood to Gaza Road

Project No.: FG6253

Probe No: VEDCP26

REPORT NO: FG6253/VEDCP26

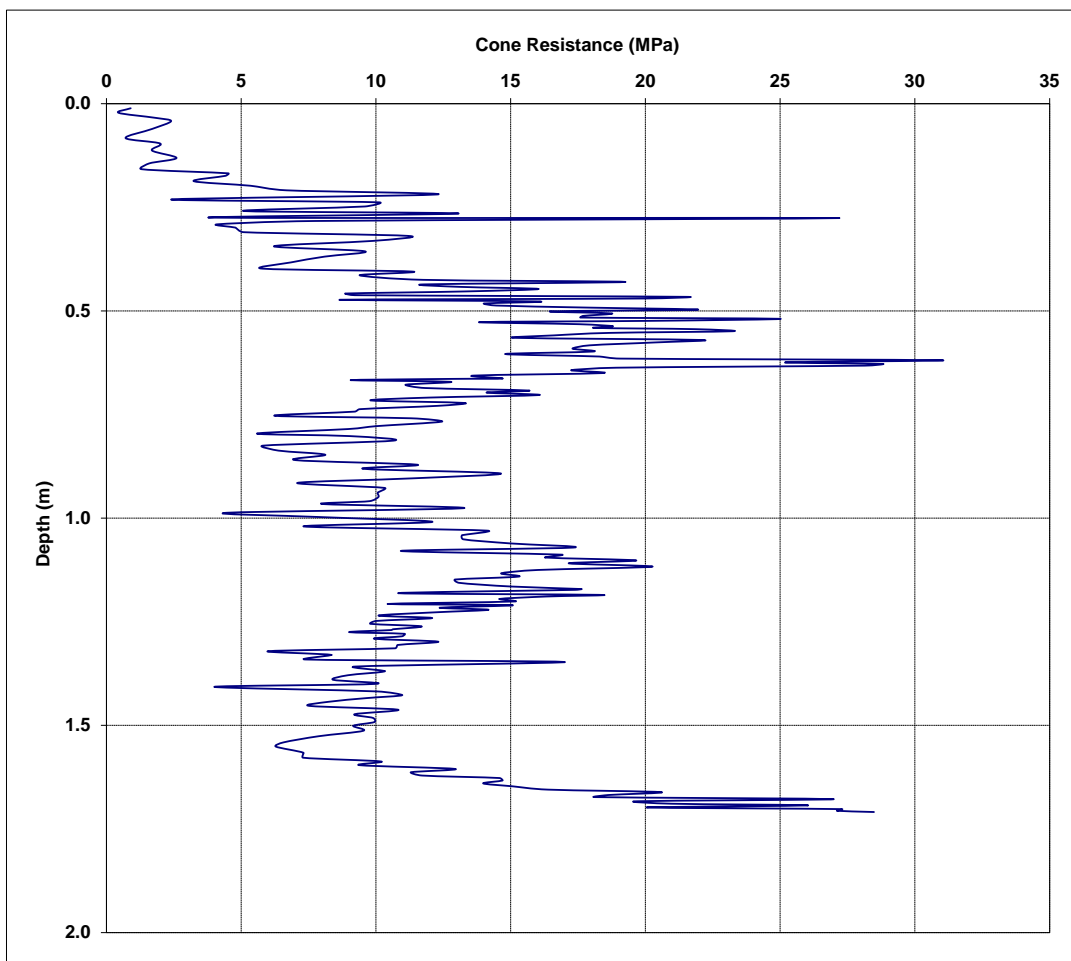
Probe Location: E0505720 N6954332

Tip Area (cm<sup>2</sup>): 4

Depth to Water Table (m): n/a
