## ENGINEERING BOREHOLE

BOREHOLE No **BH7**

PROJECT **GATEWAY UPGRADE PROJECT - GATEWAY BRIDGE FOUNDATION INVESTIGATION**

LOCATION **PIER 4 - DOWNSTREAM/RIGHTHAND SIDE**

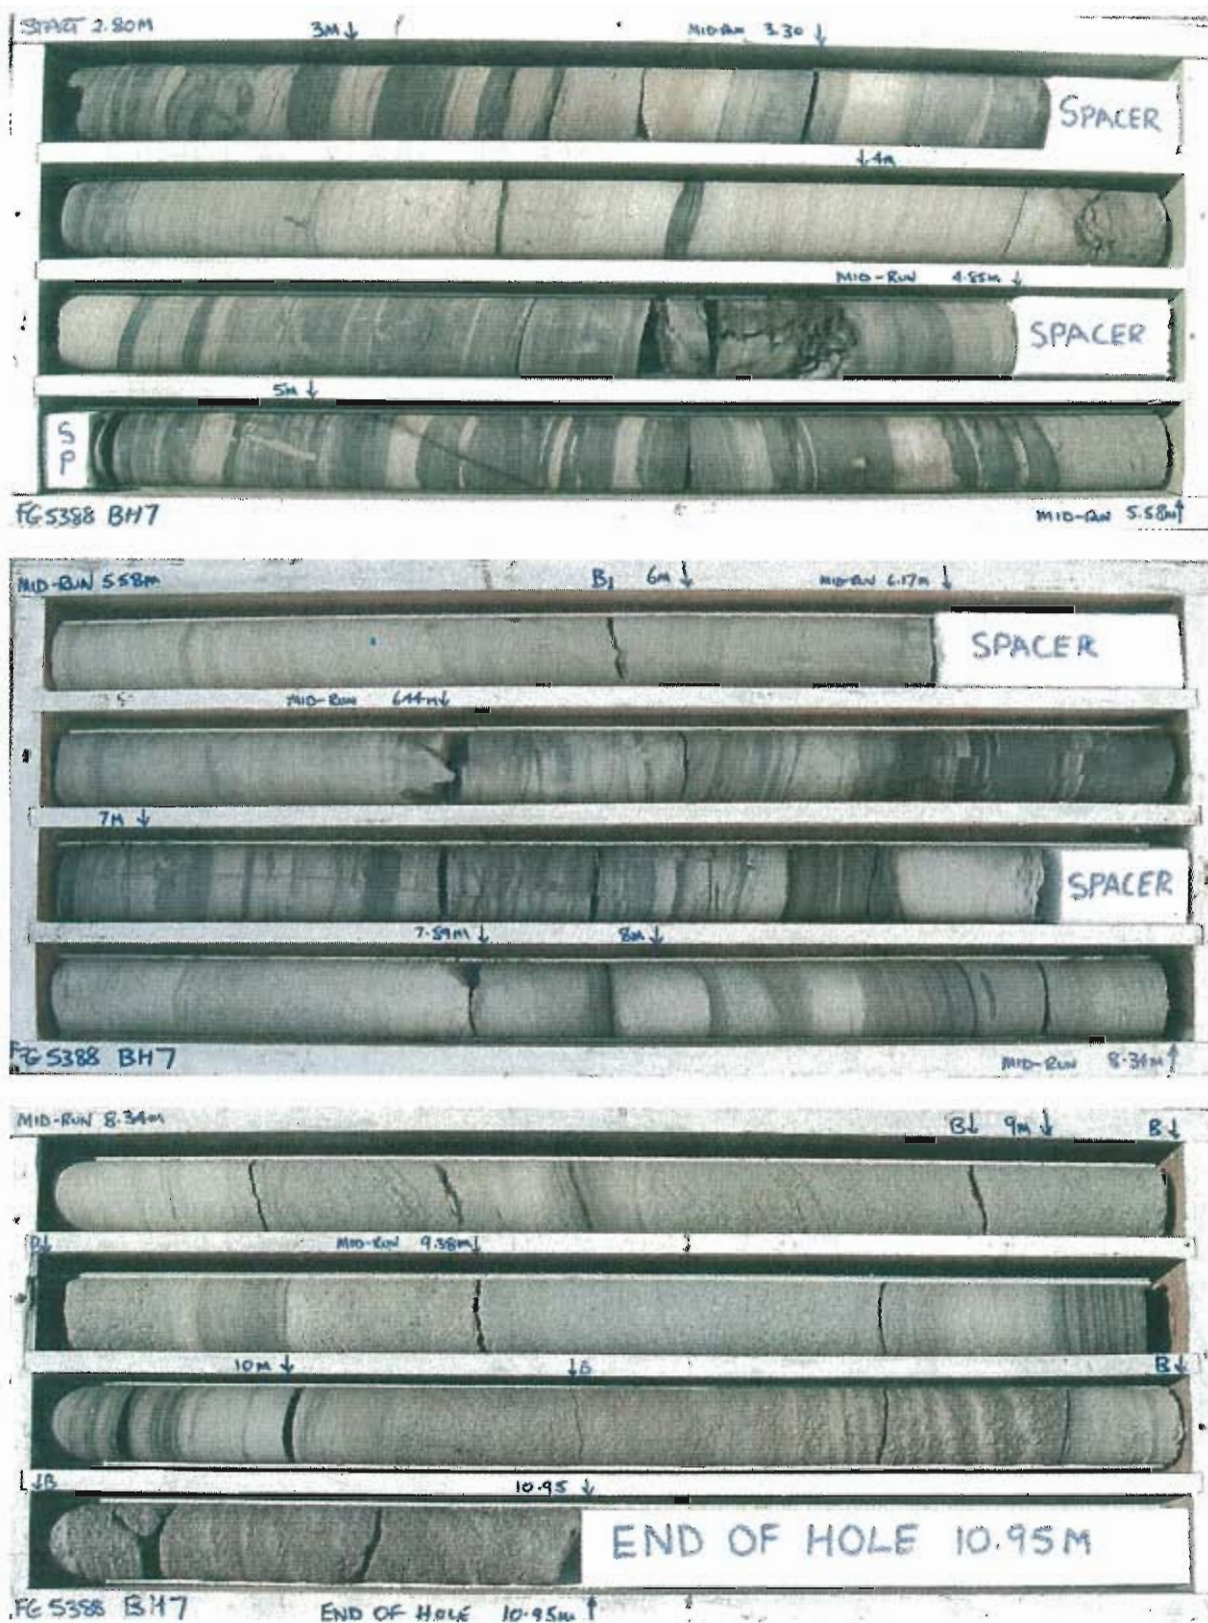
Borehole No: BH 7

Project: Gateway Upgrade Project - Gateway Bridge

Start Depth: 2.80m

Finish Depth: 10.95m
