**GEOTECHNICAL
BOREHOLE LOG**

BOREHOLE No **BH276**

PROJECT	Mackay Ring Road		
LOCATION	Stage 2 Overpass	COORDINATES 721249.6 E; 7663233.8 N	
PROJECT No	FG6184	SURFACE RL 15.21m	PLUNGE 90°
			DATE STARTED 22/09/2015
			GRID DATUM GDA 94 / MGA Z55
JOB No	242/10G/906	HEIGHT DATUM A.H.D.	BEARING °
			DATE COMPLETED 22/09/2015
			DRILLER Saxon Drilling

CORE PHOTO LOG

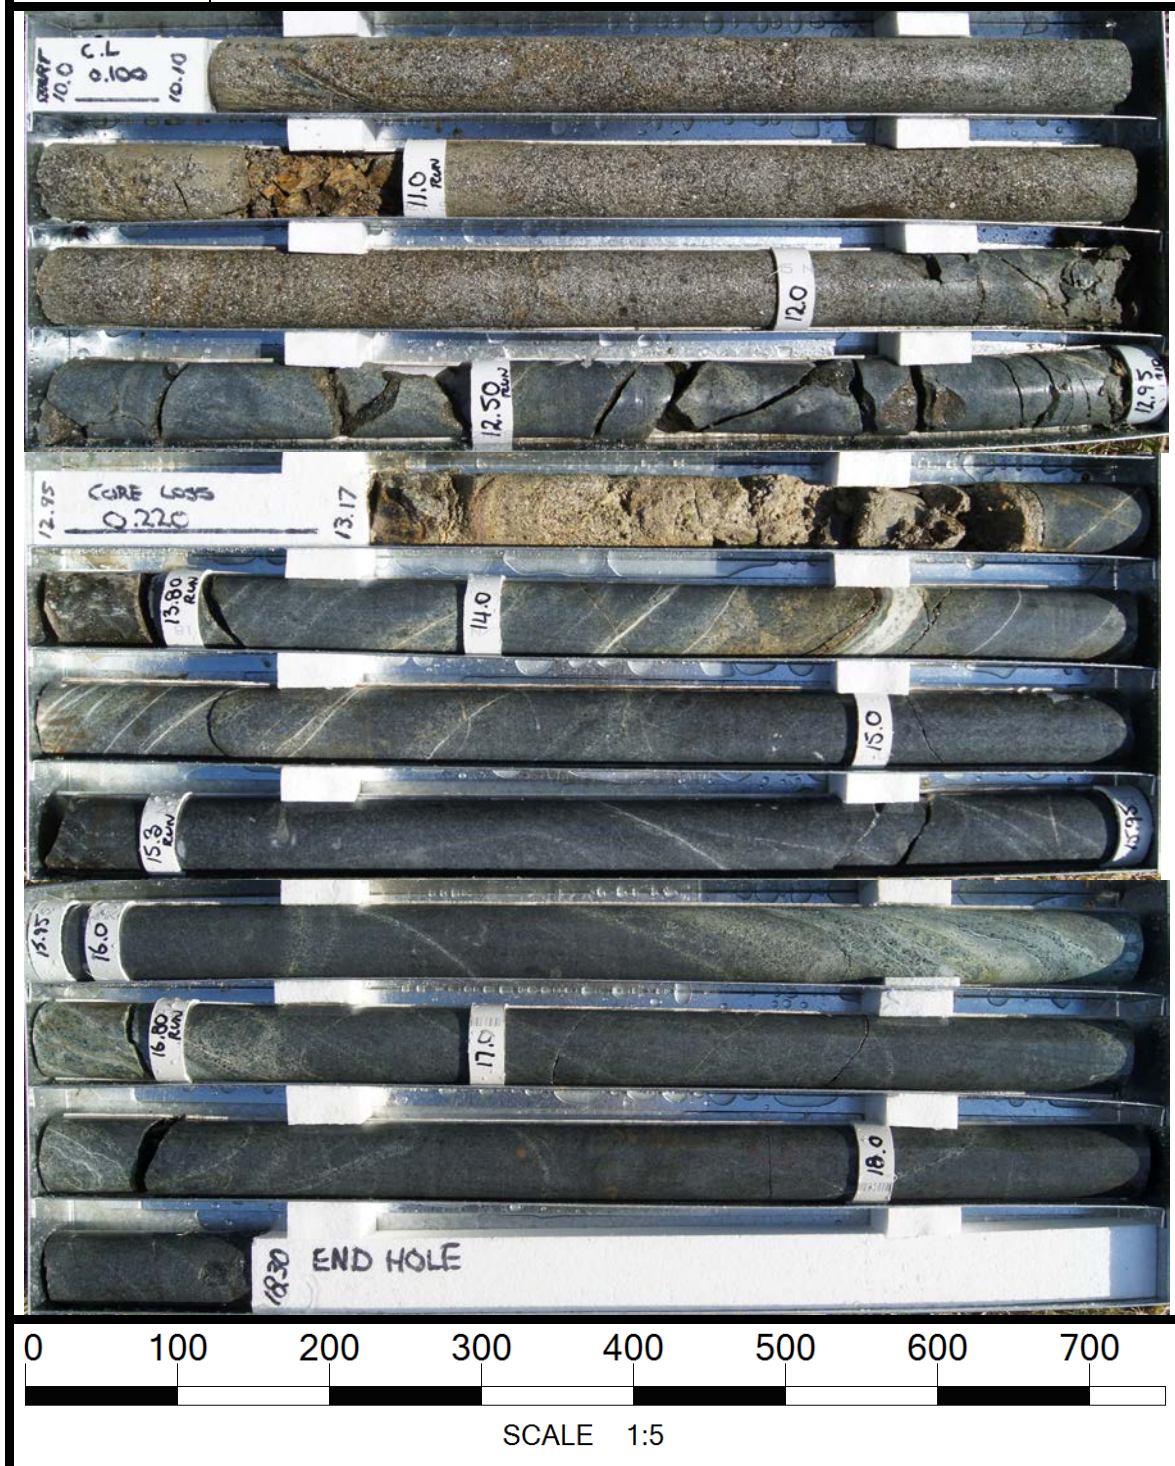
Project Name	Mackay Ring Road Stage 2		
Project No.	FG 6184	Date	22/09/15
Borehole No.	BH 276	TMR H No.	H12428
Location	Port Access Rd Overpass Abutment B	Start Depth (m)	10.00
Detail		Finish Depth (m)	18.30
Chainage		Submitted By	BW
Remarks
