# ENGINEERING BOREHOLE

BOREHOLE No     BH38

PROJECT IPSWICH MOTORWAY / LOGAN MOTORWAY GEOTECHNICAL INVESTIGATION

LOCATION Bertha St O'pass. Near Abutment B, Approximate Chainage 12898m, 26m right of control MC20. COORDINATES 28566.2 E; 146963.8 N

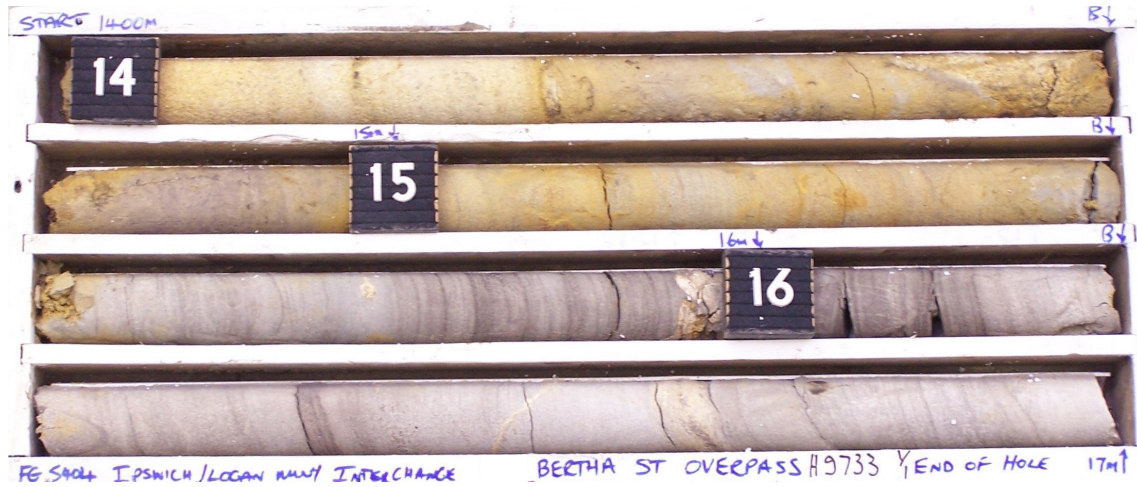
Project: **Ipswich Motorway / Logan Motorway Interchange**  
Borehole No: **BH38**  
Start Depth: 14.00m  
Finish Depth: 17.00m  
Project No: FG5404  
H No: 9733

15															Is(50)=0.15 MPa Is(50)=0.16 MPa	x o	
16	-6.45														Jt, 70°, PL-Un, SR, T, 1mm CL infill. Is(50)=0.16 MPa Is(50)=0.24 MPa	x o	
17	-6.90		100				SW								Brecciated / Faulted zone, 30mm thick on Jt, 45°, PL, SR, slickensided. Resembles gravelly fragments in a clayey sand matrix, very dense. Is(50)=0.23 MPa Is(50)=0.25 MPa	x o	
17						Borehole terminated at 17m											
18																	
19																	
20
