# REPORT OF BOREHOLE: BH426

PROJECT: Gold Coast Rapid Transit SURFACE RL: 4.63 m DATUM: AHD

## REPORT OF PHOTOGRAPHS: BH426

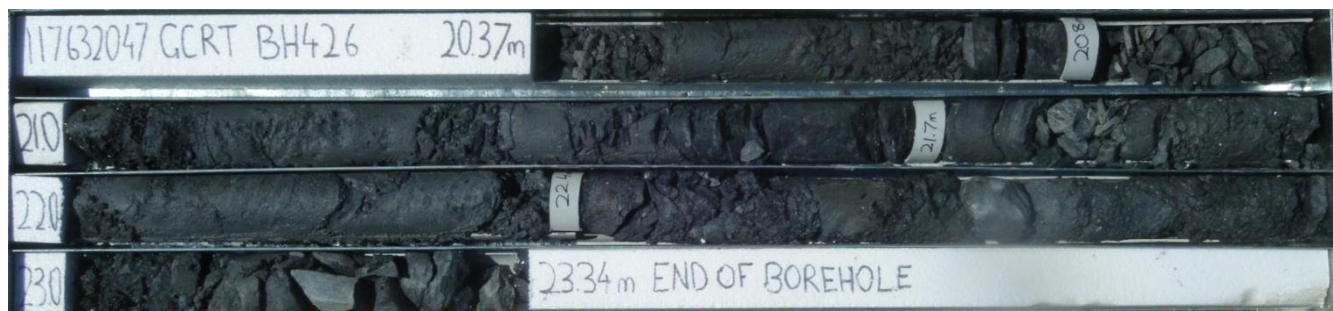
**20.37 – 23.34 m**

DEPTH RANGE: 20.37 – 23.34 m  
DRILL RIG: Hydrapower Scout  
DRILLER: Geodrill Pty Ltd  
LOGGED: BT DATE: 7/9/11  
CHECKED: NK DATE: 25/9/11

| Drilling | | | | | Field Material Description | | | | | Defect Information | | | | |
|---|---|---|---|---|---|---|---|---|---|---|--|--|---|--|
| | | | | -15.74 | | | ARGILLITE | MW | | | | | | |
| | | | | 20.5 | | | fine grained, dark grey, bedded, dipping 10-20°, quartz veins up to 2 mm thick at approximate spacings of 5 mm in places | | | | | | | |
