# ENGINEERING BORELOG

BOREHOLE No : 139  
 SHEET : 1 OF 2  
 REFERENCE No : H8092

PROJECT : PACIFIC MOTORWAY LOGAN RIVER SERVICE ROAD BRIDGE FOUNDATION INVESTIGATION  
 LOCATION : Pier 2 Grig ref.19549E 140097N  
 PROJECT No : MP1006 SURFACE R.L. : 3.77 DRILLER : FOUNDRIL  
 JOB No : \_\_\_\_\_ DATUM : AHD DATE DRILLED : 05/09/97

PACIFIC MOTORWAY  
LOGAN RIVER BRIDGES

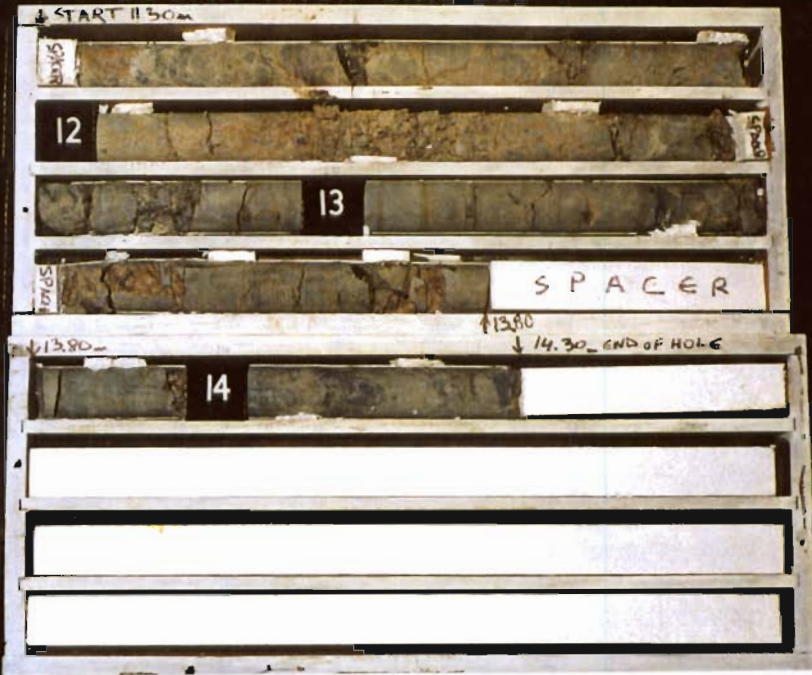
HOLE 139  
START 11-30  
END 14-30

H 8092  
1 OF 1  
SEP 1997
