BOREHOLE: BHLRMUR-06

| Project: | Pioneer-Burdekin PHES | Position: | Lower Reservoir | Sheet | 1 of 5 |

Pioneer Burdekin Pumped Hydro Energy Storage: Tranche 2 – BHLRMUR-06 Defects List

| | TITLE<br><br>Queensland Hydro<br>Netherdale/Dalrymple Heights<br>Pioneer-Burdekin PHES<br>Core photo - BHLRMUR-06 | DRAWN<br>RC | DATE<br>11/11/2024 | | |

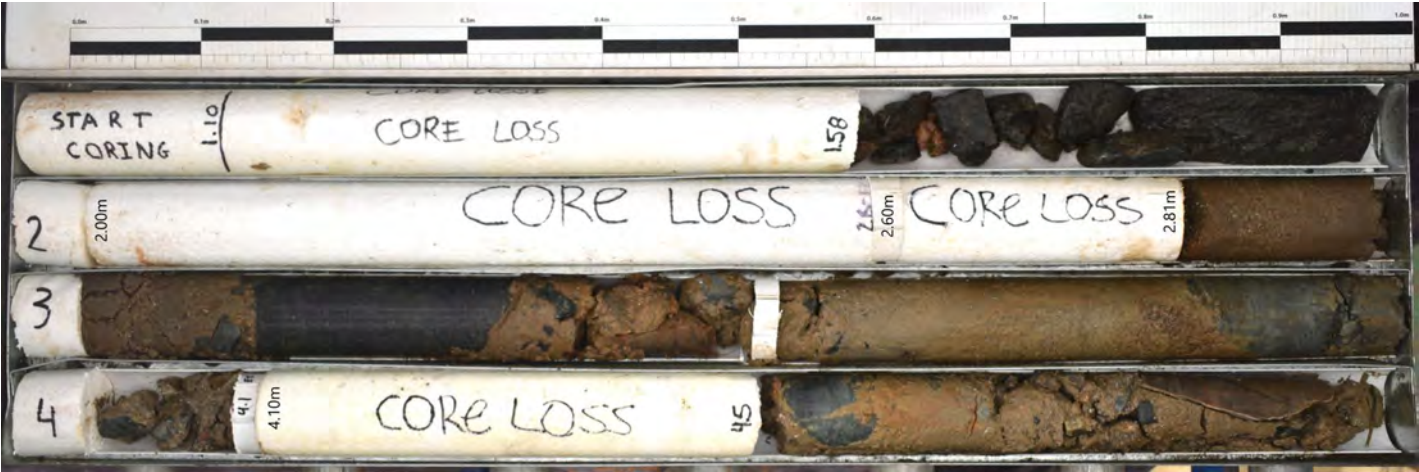
PointID : BHLRMUR-06 Depth Range: 1.00 - 5.00 m

| Drilling | | | | | Field Material Description | | | | Defect Information | | | |
|---|---|---|---|---|---|---|---|---|---|---|--|---|
| | | 28 | 0 | 2 | 2.00 | | Gravelly BOULDERS WITH COBBLES: poorly graded, sub-angular, dark grey, cobbles are <= 200mm, sub-angular; gravel is medium to coarse grained, sub-rounded to sub-angular, mafic igneous origin; (COLLUVIUM). | | | | | |
| | | | | 3 | 3.10 | | SC Clayey SAND: fine to coarse grained, well graded, dark grey, brown, clay is low plasticity; with fine to medium grained, sub-rounded gravel; (COLLUVIUM). | | | | | |
| | | 86 | 0 | | 3.55 | | Gravelly Clayey BOULDERS: sub-angular, dark grey and brown, clay is medium plasticity; gravel is fine to coarse grained, sub-rounded to sub-angular; (COLLUVIUM). | | | | | |
| | | | | 4 | 4.10 | | Gravelly Clayey COBBLES: sub-angular, grey and dark grey, clay is medium plasticity; gravel is fine to coarse grained, sub-angular; with fine to coarse grained sand; (COLLUVIUM). | | | | | |

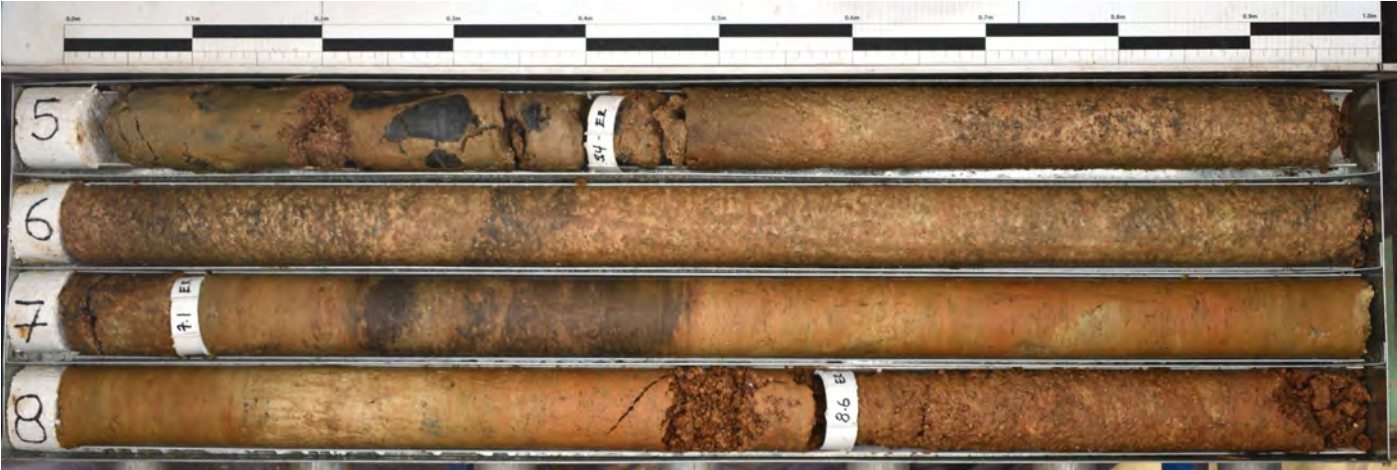
PointID : BHLRMUR-06 Depth Range: 5.00 - 9.00 m

| Drilling | | | | | Field Material Description | | | | Defect Information | | | |
|---|---|---|---|---|---|---|---|---|---|---|--|---|
| | | 69 | 0 | | | | CI-CH Gravelly Sandy CLAY: medium to high plasticity, dark grey, brown, sand is fine to coarse grained; gravel is medium to coarse grained, sub-angular; with sub-angular, up to 150mm boulders; (COLLUVIUM). | | | | | |
| | | | | 6 | | | CI-CH Gravelly Sandy CLAY: medium to high plasticity, pale brown to brown, sand is fine to coarse grained; gravel is fine grained, sub-angular. | XW | | | | |
| | | | | 208.71 | | | CI-CH: pale brown to orange. Brown mottled dark grey. | RS | | | | |

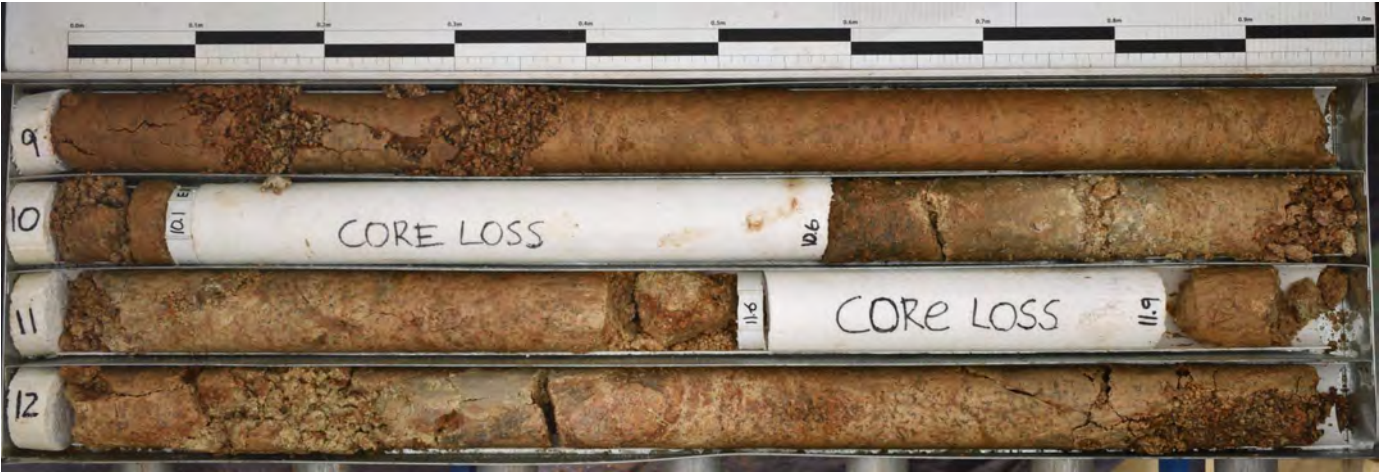
PointID : BHLRMUR-06 Depth Range: 9.00 - 13.00 m

| Drilling | | | | | Field Material Description | | | Defect Information | | |
|---|---|---|---|---|---|---|---|---|---|---|
| | | 67 | 0 | 11 | 10.60<br>205.33 | CI-CH Gravelly Sandy CLAY: medium to high plasticity, dark grey, brown, sand is fine to coarse grained; gravel is fine grained, sub-angular. | XW | | 10.66: J, 10°, clay, gravel CT, UN, RF | |
| | | | | | | | RS | | 11.05-11.15: J, 55°, clay, gravel CT, UN, RF<br>11.16-11.30: J, 45 - 90°, UN, RF | |
| | | 73 | 0 | 12 | 11.90<br>204.03 | GRANODIORITE: medium to coarse grained, pink, orange, pale grey, grey brown, crystalline, massive. | XW | | 12.00-12.28: J, 80 - 90°, Fe SN, UN, RF<br>12.36: J, 10°, clay VN, UN, RF<br>12.67-12.83: J, 65°, clay, sand, UN, RF | |

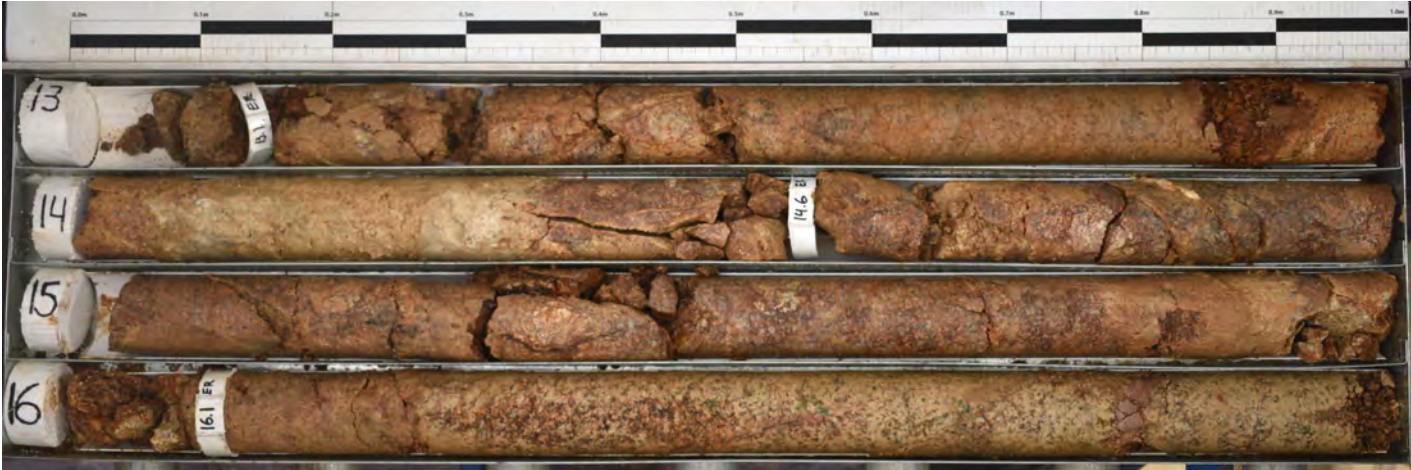
PointID : BHLRMUR-06 Depth Range: 13.00 - 17.00 m

| Drilling | | | | | Field Material Description | | | Defect Information | | |
|---|---|---|---|---|---|---|---|---|---|---|
| | | 100 | 47 | 14 | | 14.35-16.20m: red to brown Fe cementation | HW | | 14.30-14.60: J, 70°, br VN, UN, RF<br>14.55: J, 10°, SN, IR, RF<br>14.65: J, 25°, SN, IR, RF<br>14.76-14.82: J x2, 40°, SN, PR, SM<br>14.86-14.93: J x2, 45°, SN, PR, RF<br>15.13: J, 50°, SN, PR, RF<br>15.17-15.25: J /DB, 5 - 10°, SN, UN, RF<br>15.46: J, 10°, SN, PR, RF<br>15.40-15.55: J, 85°, SN, UN, RF<br>15.67: J, 5°, SN, PR, RF<br>15.80-15.95: J x3, 30 - 40°, SN, PR, RF | |
| | | 100 | 47 | 15 | | | | | 16.10-16.25: J X3, 10 - 20°, SN, UN, RF<br>16.27: J, 20°, PR | |
| | | | | 16 | | | XW | | 16.78-16.80: IS/J, 30°, CT, PR, RF<br>16.80: VN, 35°, pk | |

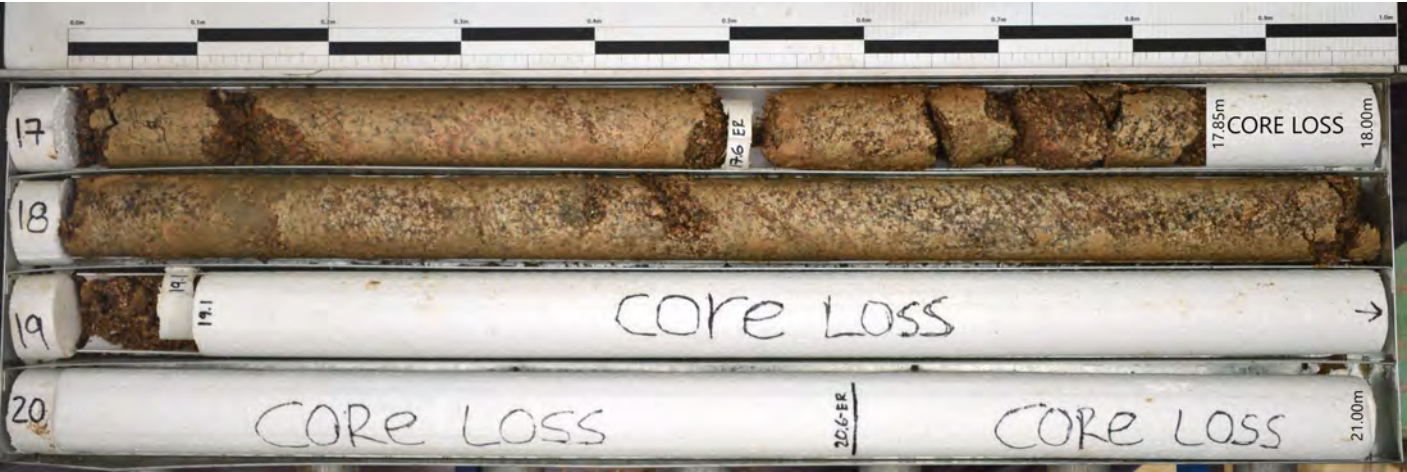
PointID : BHLRMUR-06 Depth Range: 17.00 - 21.00 m

| Drilling | | | | | Field Material Description | | | Defect Information | | |
|---|---|---|---|---|---|---|---|---|---|---|
| | | 100 | 0 | 17 | 17.00<br>198.93 | Black and grey mottled. | | | 17.50-17.85: J x3, 10 - 20°, Fe SN, IR, RF, 30-100mm spacing | |
| | | 93 | 0 | | | GRANODIORITE: medium to coarse grained, pink, orange, pale grey, grey brown, crystalline, massive. | | | | |
| | | | | 19 | 19.10<br>196.83 | NO CORE 1.90m (19.10-21.00) | | | | |

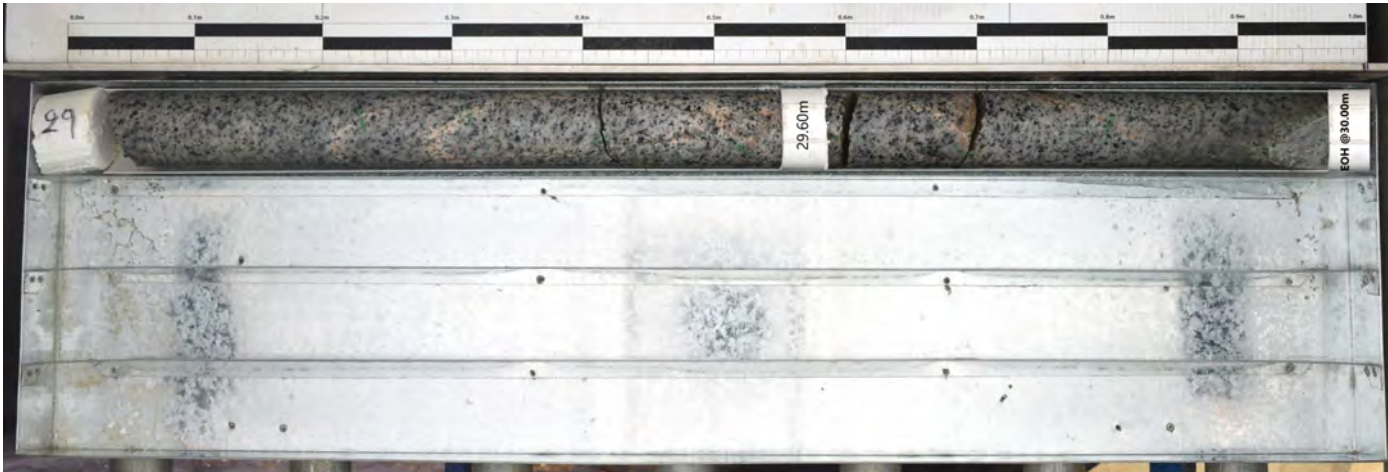
PointID : BHLRMUR-06 Depth Range: 29.00 - 30.00 m

| Drilling | | | | | | Field Material Description | | | | Defect Information | | | |
|---|---|---|---|---|---|---|---|---|---|---|--|---|--|
| | | | | 30 | | | | | | 29.97: J, 75°, wh CT, PR, SM | | | |
