ENGINEERING BOREHOLE LOG

BOREHOLE No BH C66
 SHEET 1 of 1
 REFERENCE No H11146

PROJECT Bruce Highway Upgrade (Cooroy to Curra) Section C
 LOCATION Embankment 7 COORDINATES 472312.2 E; 7093138.7 N
 PROJECT No FG5799 SURFACE R.L. 68.90m PLUNGE _____ DATE STARTED 06/08/11 GRID DATUM MGA94
 JOB No 232/10A/2 HEIGHT DATUM AHD BEARING _____ DATE COMPLETED 06/08/11 DRILLER Drillsure Pty Ltd

CORE PHOTO LOG - BH C66

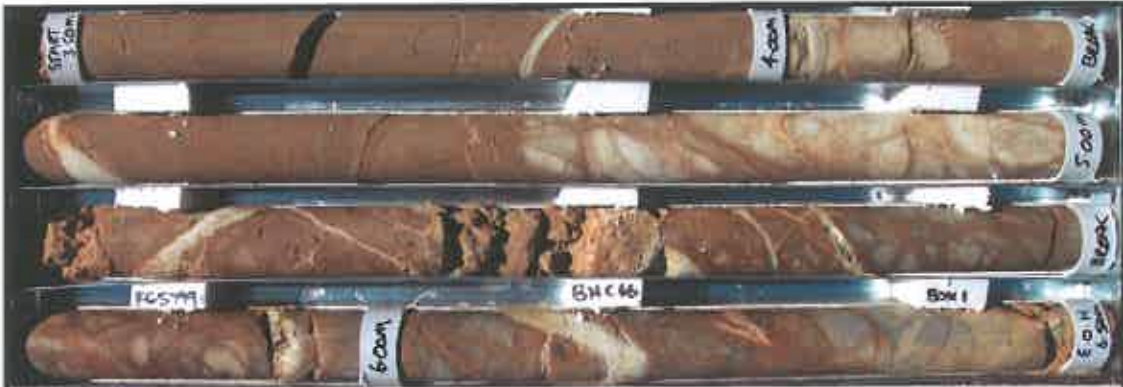
Project Name:	BRUCE HIGHWAY UPGRADE - SECTION C		
Project No.:	FG5799	Date:	08/09/2011
Details:	Embankment 7	Start Depth (m):	3.50
Reference No.:	H11146	Finish Depth (m):	6.50
