**GEOTECHNICAL  
BOREHOLE LOG**

BOREHOLE No **BH25**

REFERENCE No **H12289**

PROJECT	Veloway 1 Stage E: Birdwood to Gaza Road				
LOCATION	Gaza Rd Overpass		COORDINATES 505722.8 E; 6954348.8 N		
PROJECT No	FG6253	SURFACE RL	32.54m	PLUNGE	90°
				DATE STARTED	24/06/2015
				GRID DATUM	MGA94 Zone 56
JOB No	201/C001/4	HEIGHT DATUM	AHD	BEARING	°
				DATE COMPLETED	25/06/2015
				DRILLER	North Coast Drilling

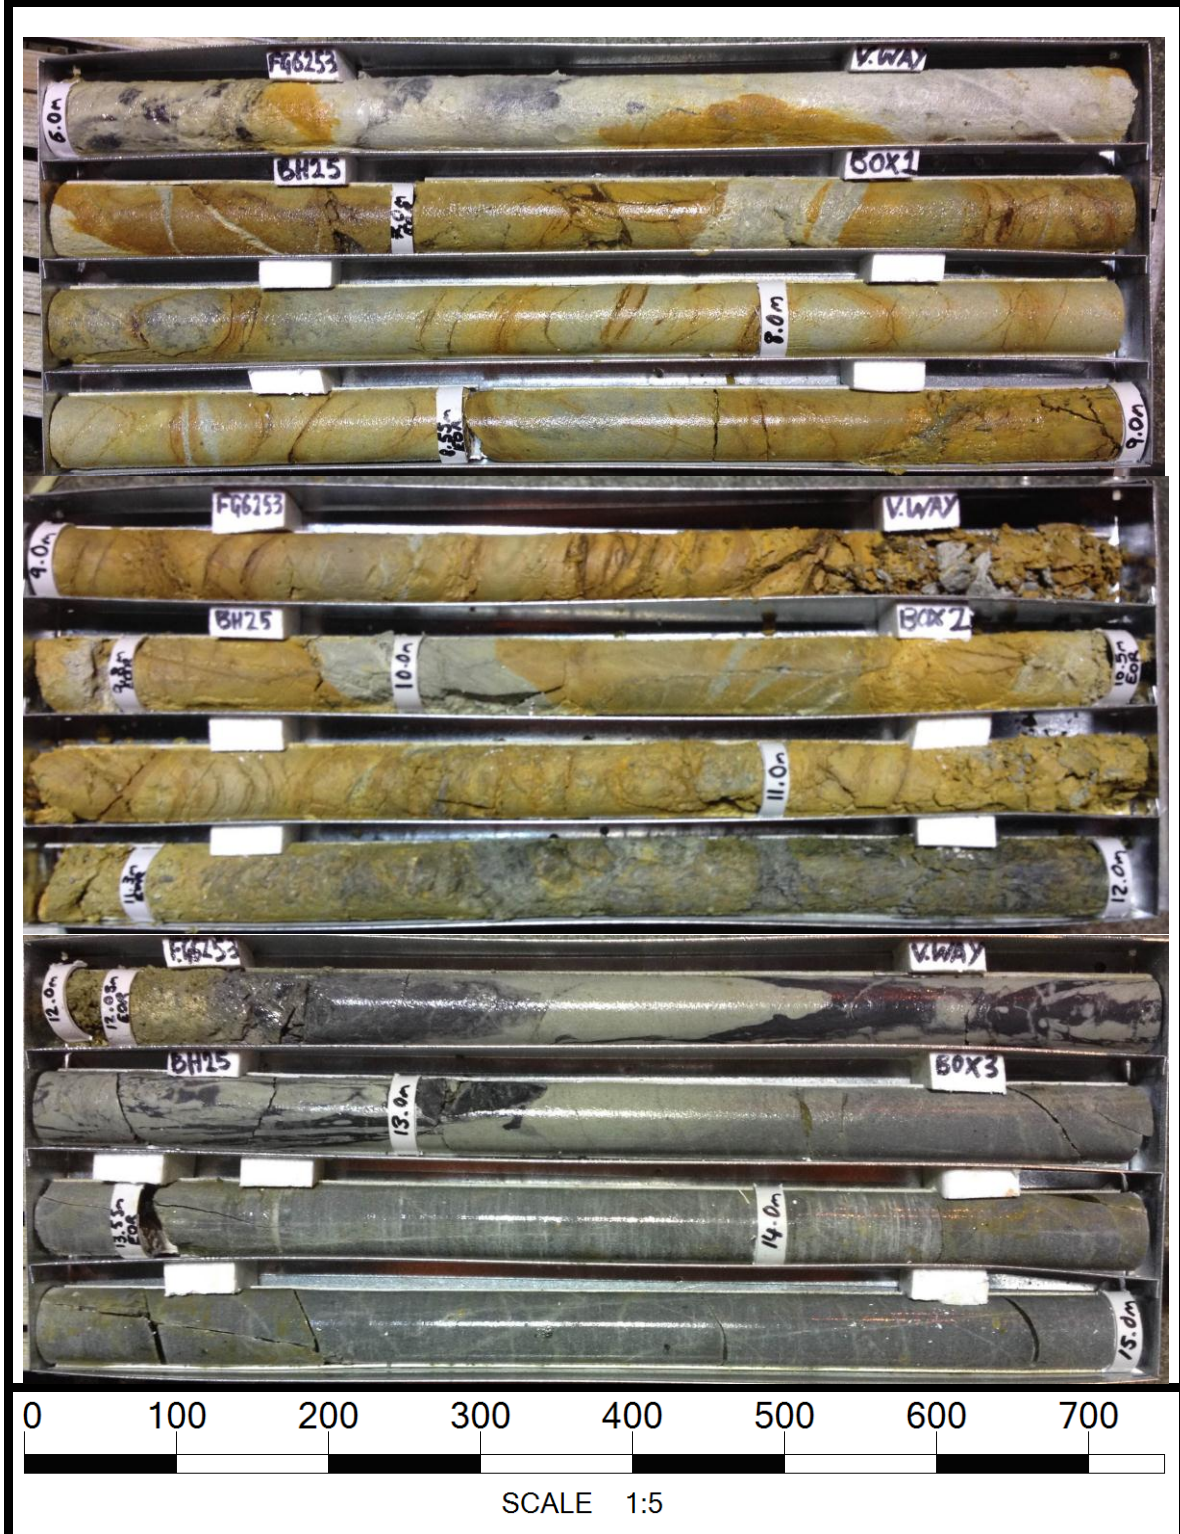
**CORE PHOTO LOG**

Project Name	<b>Velway (V1), Section E: Birdwood to Gaza Road</b>		
Project No	FG6253	Date	02/07/15
Borehole No	BH 25	TMR H No	12289
Location	Gaza Rd Overpass	Start Depth (m)	6.0
Detail		Finish Depth (m)	15.0
Chainage		Submitted By	TJG
Remarks
