## GEOTECHNICAL BOREHOLE LOG

BOREHOLE No **BH26**

PROJECT Centenary Bridge Upgrade

**CORE PHOTO LOG**  
DEPARTMENT OF TRANSPORT AND MAIN ROADS  
GEOTECHNICAL SECTION

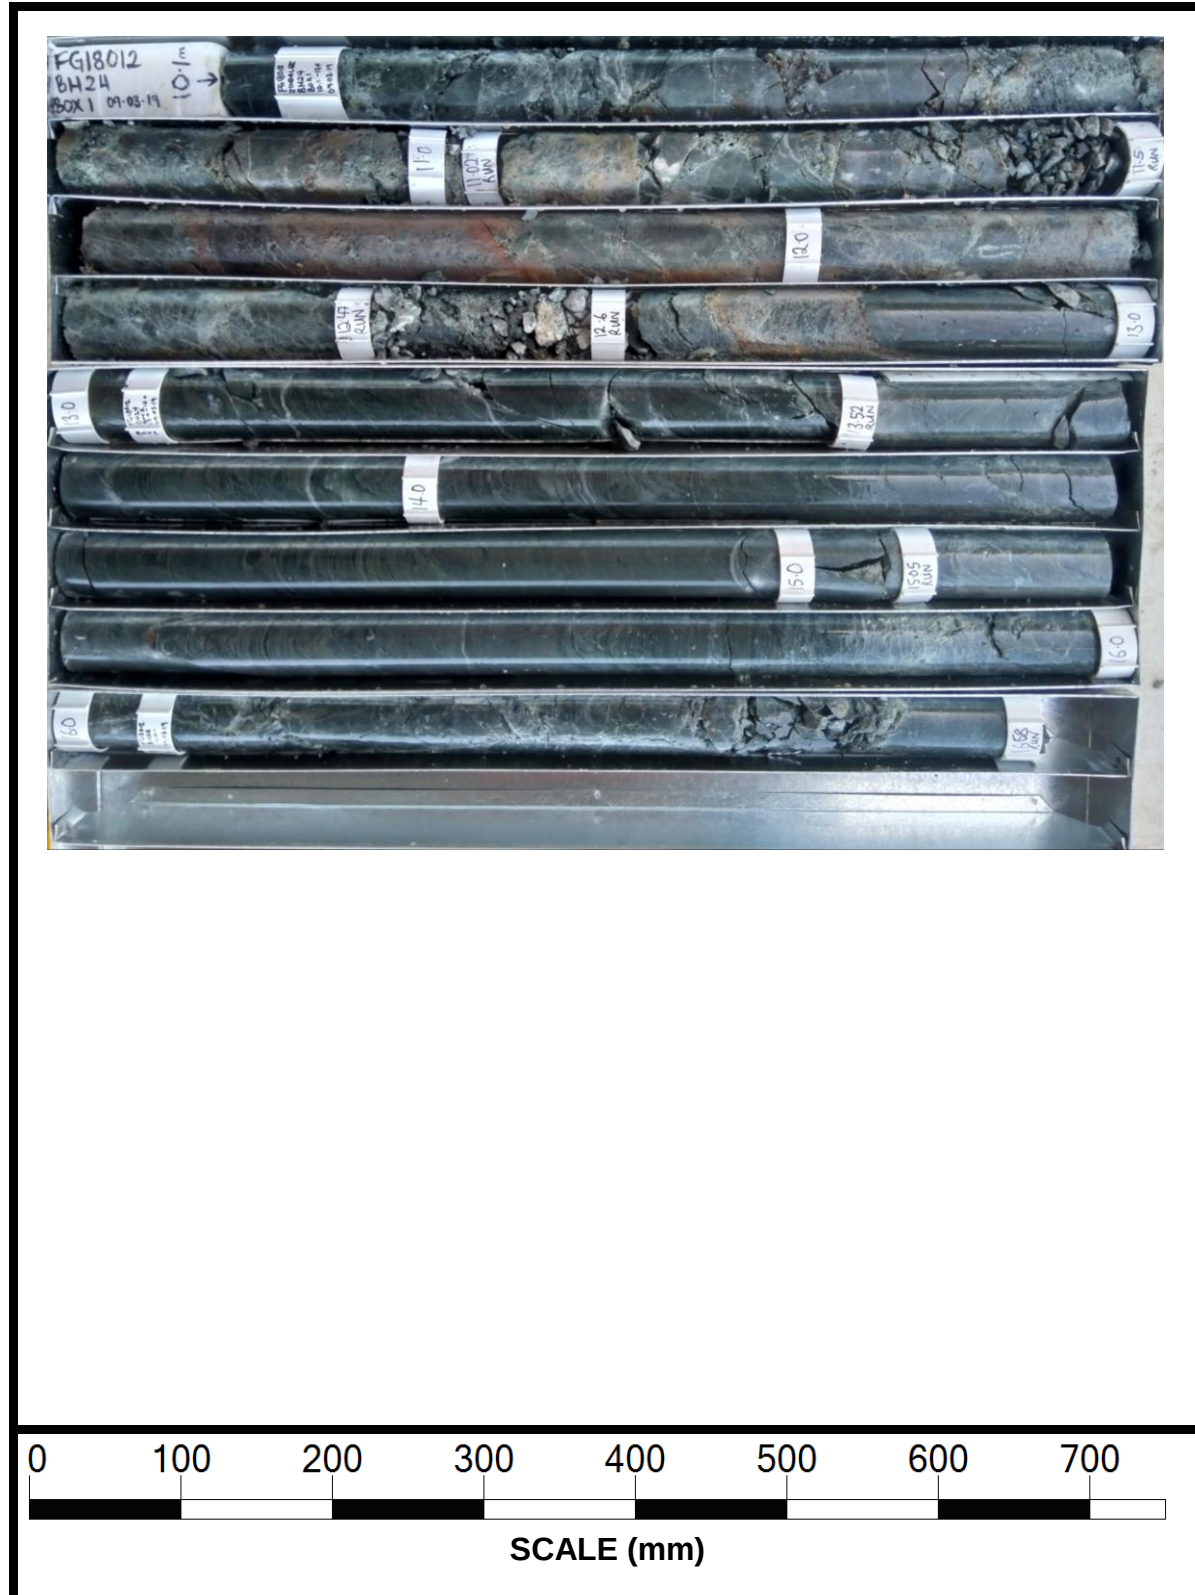
| DEPTH (m) | R.L. (m) | AUGER CASING WASH BORING CORE DRILLING | RQD (%)<br>CORE REC % | SAMPLE | MATERIAL DESCRIPTION | LITHOLOGY<br>GROUP SYMBOL / WEATHERING | INTACT STRENGTH<br>EH<br>VH<br>H<br>M<br>L<br>VL | DEFECT SPACING<br>EC<br>VC<br>C<br>M<br>W<br>VW | ADDITIONAL DATA AND TEST RESULTS | SAMPLES TESTS |
|---|---|---|---|---|---|---|---|---|---|---|
| | -16.12 | | (0) | G | ARGILLITE<br>MW: Dark blue to grey, fine grained, medium strength.<br>Interbedded low strength clayey bands and high strength bands, iron staining.<br>Js1: 0-30° (10-12/m), Ro, TI-FL, Cn, Cly Ct. | MW | | | 10.20m-10.21m: Clayey band. | 20/10mm hb |
| 12 | | | 100 (0) | | ARGILLITE<br>HW: Dark and pale grey mottled red brown, fine grained, low to medium strength.<br>Interbedded high strength bands, iron staining and clay infill. | HW | | | 11.16m-11.50m: Becoming Dark blue to grey.<br>Js1: 0-30° (20/m), Ro, TI-OP-FL, Cn, Cly Ct.<br>Js2: 30-50° (25/m), Ro, TI-OP-FL, Cn, Cly Ct, Fe Stn. | Is(50)=0.12 MPa<br>Is(50)=0.04 MPa<br>UCS=0.56 MPa<br>D (11.53m)<br>A (11.58m)<br>(11.61m) |
| 14 | | | | | ARGILLITE<br>SW-Fr: Dark and pale grey, fine grained, high strength.<br>Quartz veining.<br>Js1: 0-30° (3-4/m), Sm-Ro, TI, Cn.<br>Js2: 30-50° (6-8/m), Sm, TI, Cn.<br>Js3: 0-30° (6-8/m), HD, FL, Qtz. | SA | | | | Is(50)=0.96 MPa<br>Is(50)=0.33 MPa<br>D (13.94m)<br>A (13.98m) |
| 16 | | | | | From 15.8m:<br>Js1: 0-30° (4-5/m), Ro, TI-FL, Cn, Cly Ct.<br>Js2: 30-50° (5-6/m), Ro, TI-FL, Cn, Cly Ct.<br>Js: 80-90° (6-7/m), Ro, TI-FL, Cn, Cly Ct. | MA | | | | Is(50)=0.24 MPa<br>Is(50)=0.48 MPa<br>A (15.62m)<br>D (15.75m) |
| 17 | -22.18 | | 100 | | Borehole completed at 16.68 m | | | | 16.47m-16.60m: Broken zone. | |
