REPORT ON CONE PENETROMETER TEST

Client **Main Roads**
 Project **Brisbane Port Road Stage 3**
 Job Ref.
 Location **Easting 47093.000 Northing 34533.000**
 Chainage
 Sounding **CPTU128**
 Test Date **30/11/1999**
 Remarks

Project No. **C60323**
 Surface RL **2.700**
 Water Table **1.000**
 Start Depth **1.000**
 Refusal **21.650**

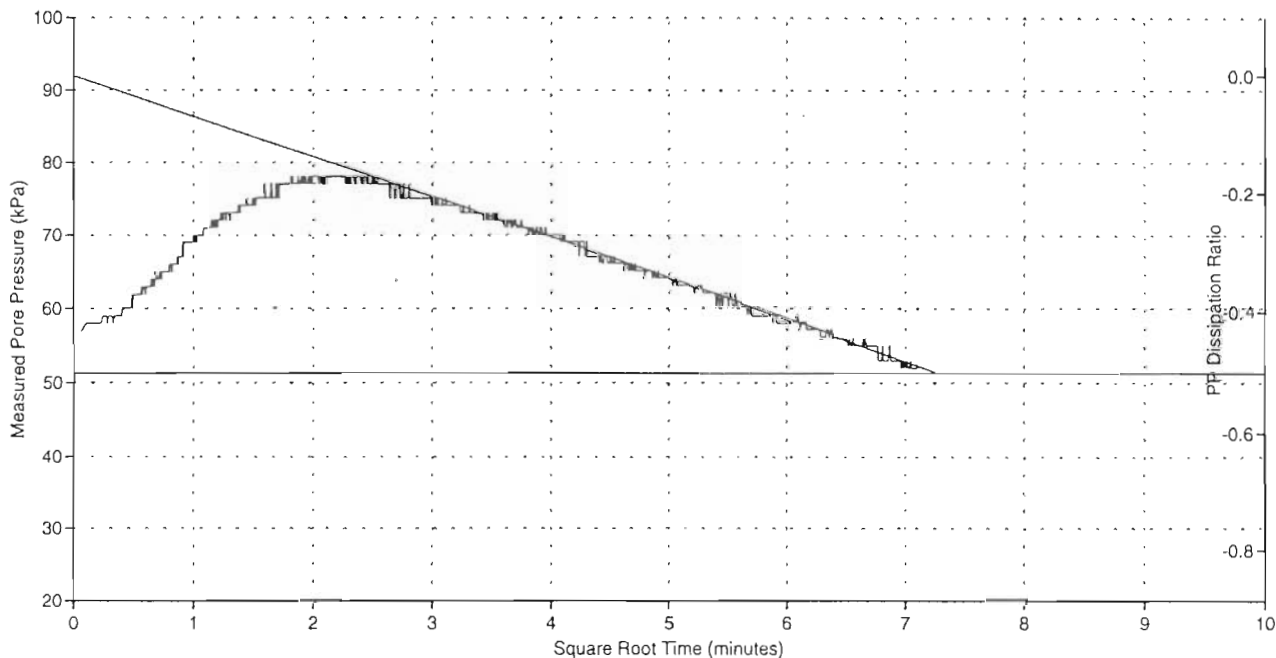
REPORT ON CPTu DISSIPATION TEST

Depth (m) **2.08**
 Start Pressure (kPa) **92**
 Dissipation (%) **50**
 Dissipation Pressure (kPa) **51**
 Time for Dissipation (min) **53.0**

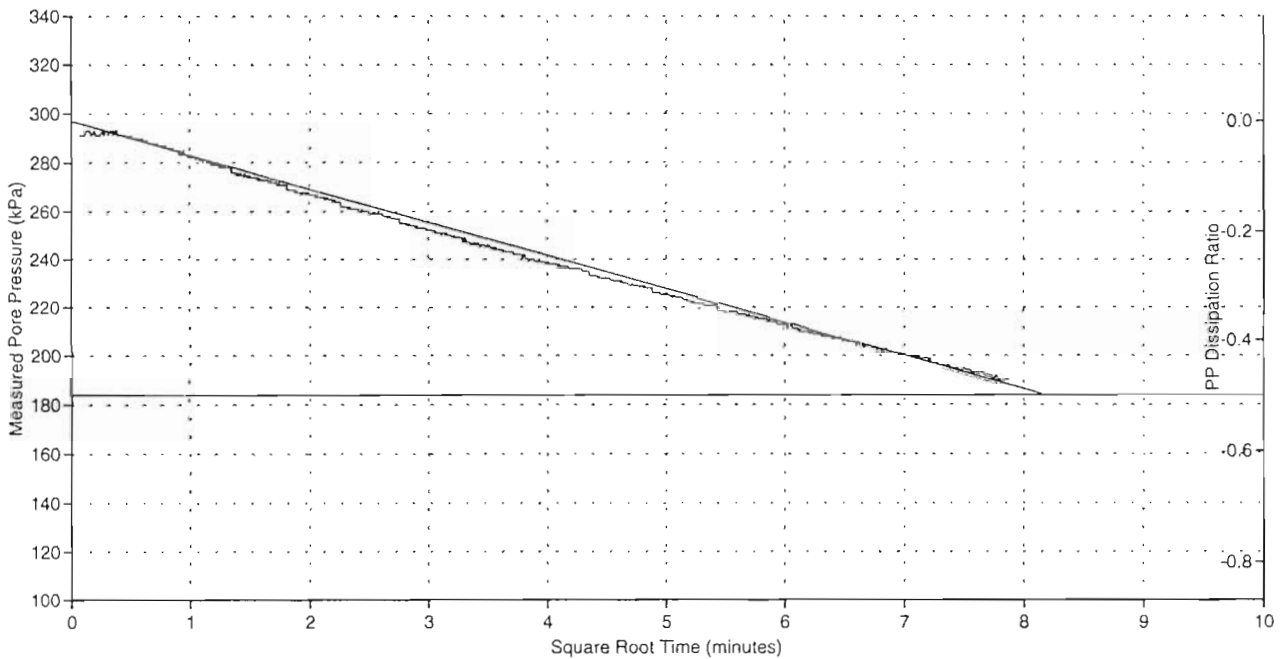
REPORT ON CPT_u DISSIPATION TEST

Depth (m) **8.18**
 Start Pressure (kPa) **297**
 Dissipation (%) **50**
 Dissipation Pressure (kPa) **184**
 Time for Dissipation (min) **67.0**

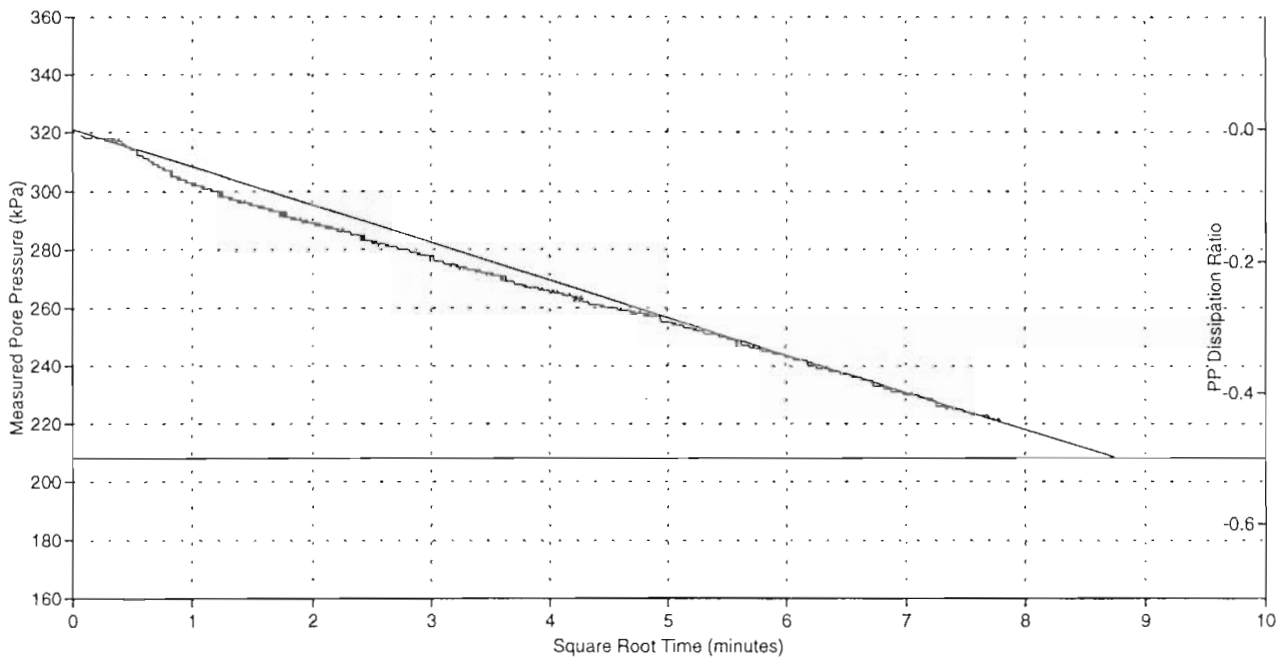
REPORT ON CPT_u DISSIPATION TEST

Depth (m) **10.70**
 Start Pressure (kPa) **321**
 Dissipation (%) **50**
 Dissipation Pressure (kPa) **208**
 Time for Dissipation (min) **77.0**

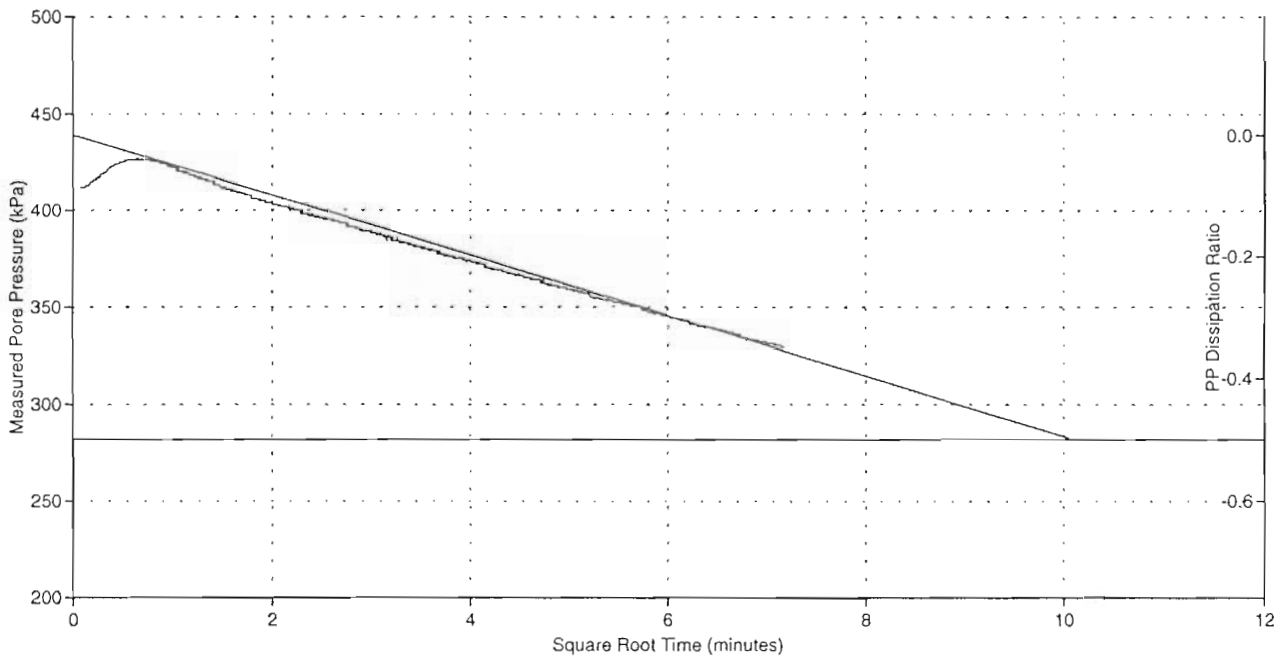
REPORT ON CPTu DISSIPATION TEST

Depth (m) **13.68**
 Start Pressure (kPa) **439**
 Dissipation (%) **50**
 Dissipation Pressure (kPa) **282**
 Time for Dissipation (min) **102**

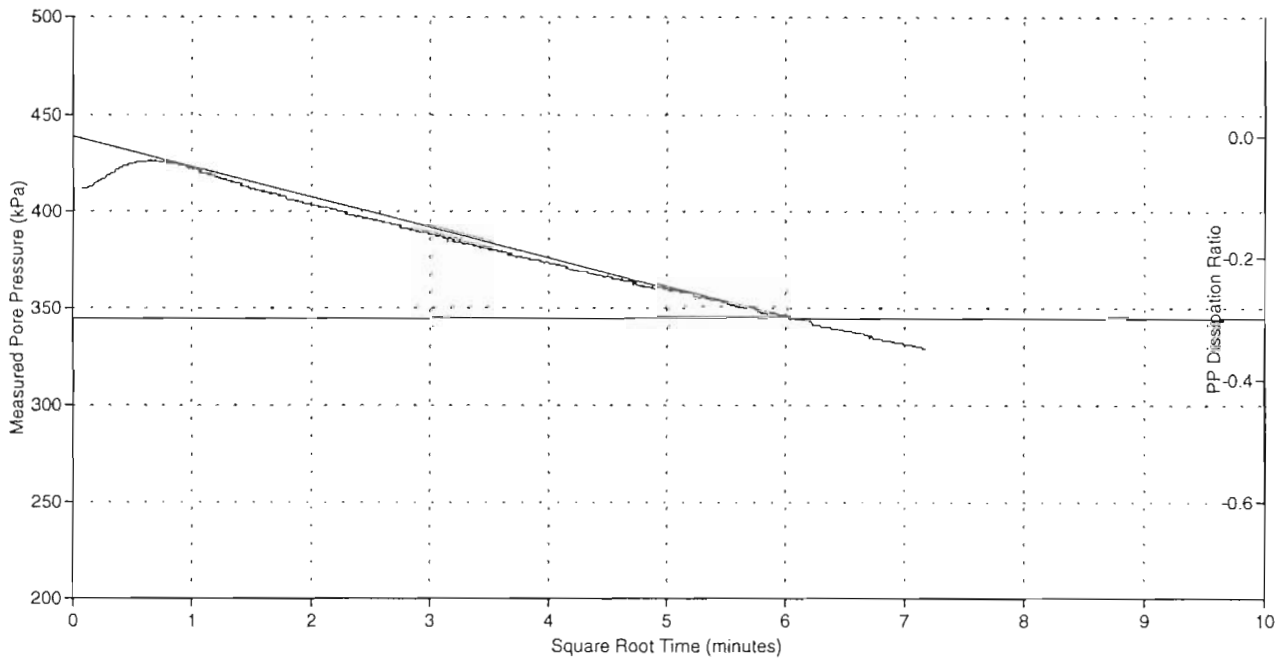
REPORT ON CPTu DISSIPATION TEST

Depth (m) **13.68**
 Start Pressure (kPa) **439**
 Dissipation (%) **30**
 Dissipation Pressure (kPa) **345**
 Time for Dissipation (min) **36.0**
