# REPORT OF BOREHOLE: BH2D13

PROJECT: Gold Coast Rapid Transit SURFACE RL: 16.53 m DATUM: AHD

## REPORT OF CORE PHOTOGRAPHS: BH2D13

CLIENT: McConnell Dowell Constructors  
PROJECT: Gold Coast Rapid Transit  
LOCATION: Zone 2  
JOB NO: 117632047

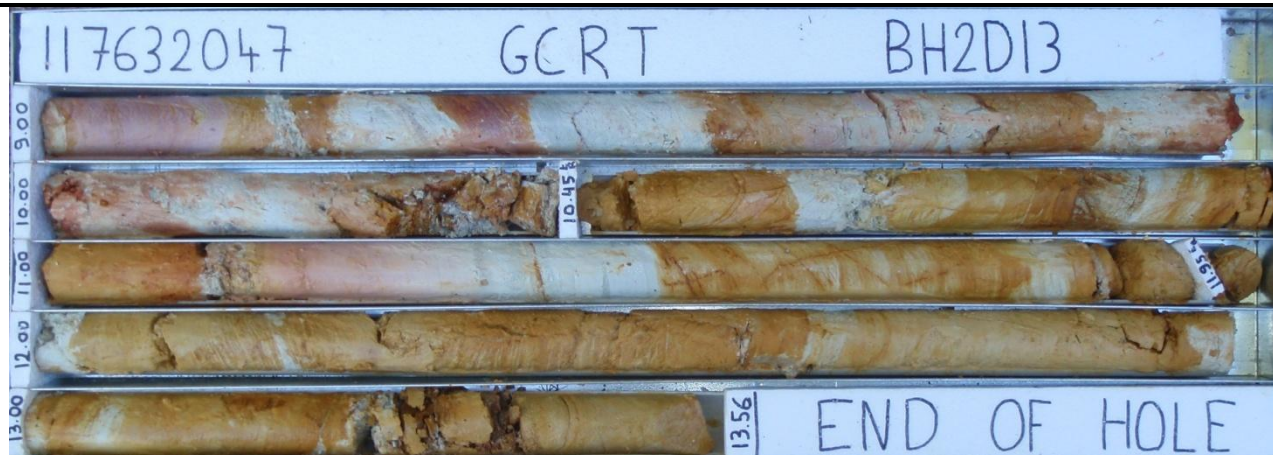
9.00 – 13.56 m

| Drilling | | | | | Field Material Description | | | | Defect Information | | | |
|---|---|---|---|---|---|---|---|---|---|---|--|---|
| NMLC | | 100 | 0 | | | | MUDSTONE<br>fine grained, pale grey orange brown and pale red brown, interbedded in places with decomposed seams and zones of pale grey silty clay, numerous healed joints | DW<br>RS<br>DW<br>RS<br>DW | | 9.25-9.35 m: DZ, pale grey silty clay<br>9.45-9.56 m: DZ, pale grey silty clay<br>9.68 m: J, 90°, Pl, Sm, Cn | | |

| Drilling | | | | | Field Material Description | | | | Defect Information | | | |
|---|---|---|---|---|---|---|---|---|---|---|--|---|
| | | | | 6.08 | | | SANDSTONE<br>medium grained, pale orange brown, bedding parting dipping at 40°, numerous dark orange brown healed joints | EW | | 10.35 m: J, 50°, Pl, Ro, Sn, FeO | | |
| | | | | 11.17 | | | interbedded with pale grey fine grained MUDSTONE between 11.17 m and 11.50 m depth | DW | | | | |
