BOREHOLE ENGINEERING LOG

BH62

| Project: | TUGUN BYPASS GEOTECHNICAL INVESTIGATION | Date Completed: | 8/7/05 |

Project: Tugun Bypass Geotechnical Investigation  
Borehole: BH62  
Start Depth: 6.76m  
Finish Depth: 11.86m

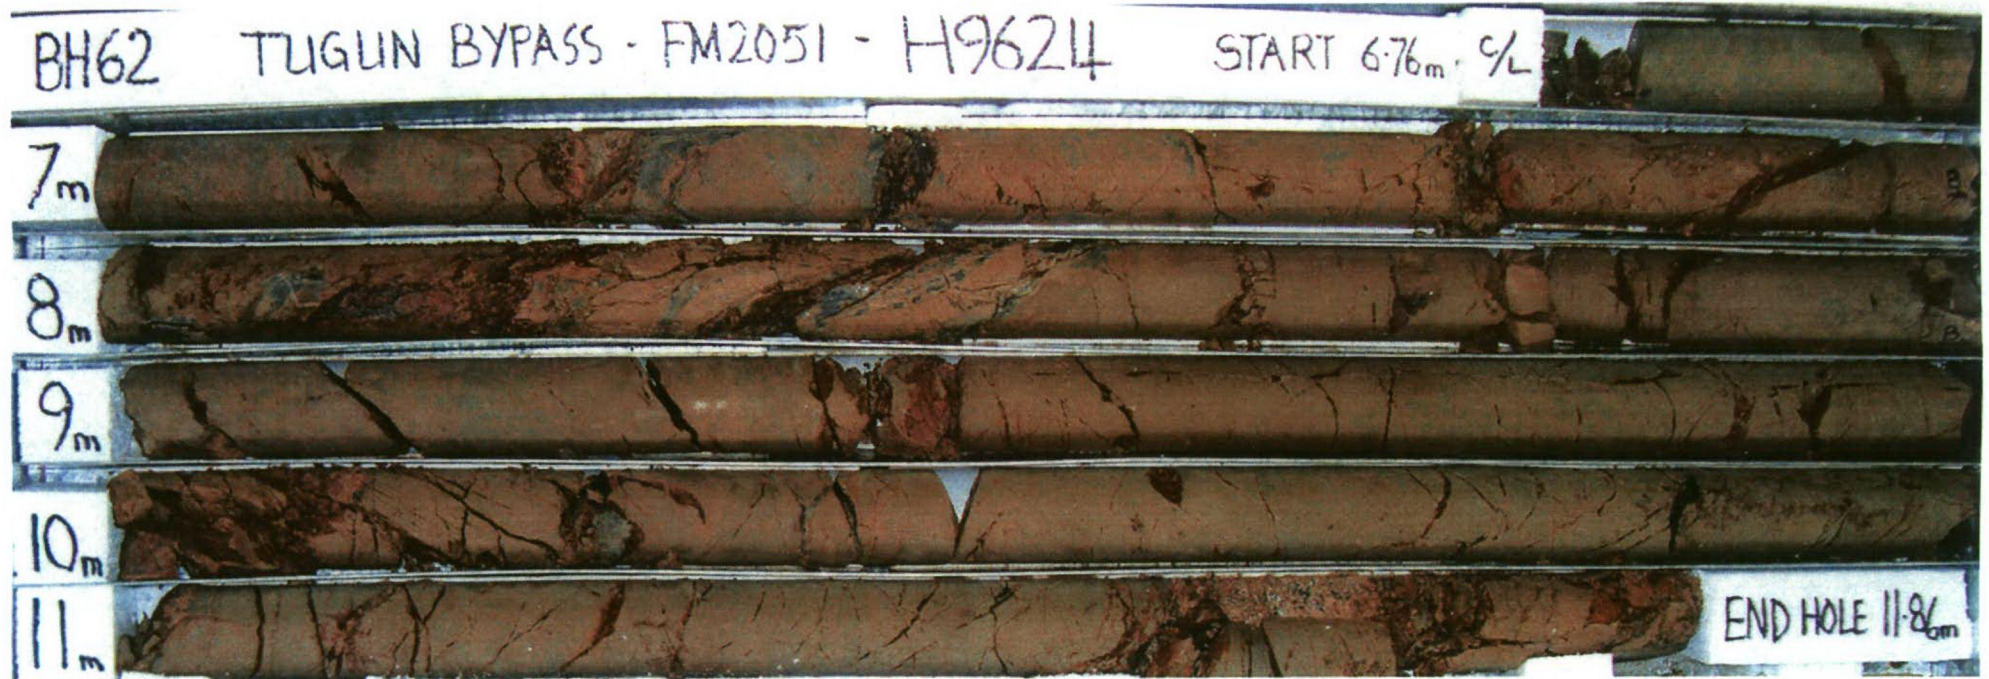
| Borehole Information | | | | | | Field Material Description | | | | | | |
|---|---|---|---|---|---|---|---|---|---|---|---|---|
| NMLC | Nil | | | | 30 | 7 | | CORE LOSS<br>GREYWACKE: fine to medium grained, pale grey, mostly stained orange-brown, ...6.79-7.24m: Silicified/quartz cemented band. ...7.24-7.34m: Argillite band. ...7.34-7.75m: fine grained greywacke band. ...7.75-8.22m: coarse grained greywacke band. ...fine to medium grained greywacke. | MW | | | 6.82m: J, sub-horizontal, smooth, planar. 6.95m: 10° - 40° J, irregular, Fe-stained. 7.00m: J, sub-horizontal, undulating. 7.14m: 40° J, fairly planar, rough. 7.24-7.34m: broken zone. 7.24 to 7.40m: 80° J, undulating, smooth. 7.58m: 65° J, planar, rough, Fe-stained.<br><br>7.89m: 70° J, planar, smooth, Fe-stained. 7.96m: J, sub-horizontal, planar, smooth, Fe-stained. 8.21m: J, sub-horizontal, irregular, rough, Fe-stained. 8.39m: 65° B, planar, smooth, Fe-stained. 8.48m: 50° - 60° B, undulating, Fe-stained. 8.74m: J, sub-horizontal, irregular, rough, Fe-stained. 8.85m: 50° J, planar, smooth, Fe-stained. 8.97m: J, sub-horizontal, planar, Fe-st. 9.06-9.15m: 2x40° J's, planar, fairly smooth, Fe-stained. 9.31m: 35° J, planar, smooth, Fe-stained. 9.39-9.45m: Broken zone. 9.52m: 40° J, planar, Fe-staining, smooth. |
