# REPORT OF BOREHOLE: BH408

PROJECT: Gold Coast Rapid Transit SURFACE RL: -3.20 m DATUM: AHD

## REPORT OF PHOTOGRAPHS: BH408

CLIENT: McConnell Dowell Constructors  
PROJECT: Gold Coast Rapid Transit  
LOCATION: Zone 4  
JOB NO: 117632047

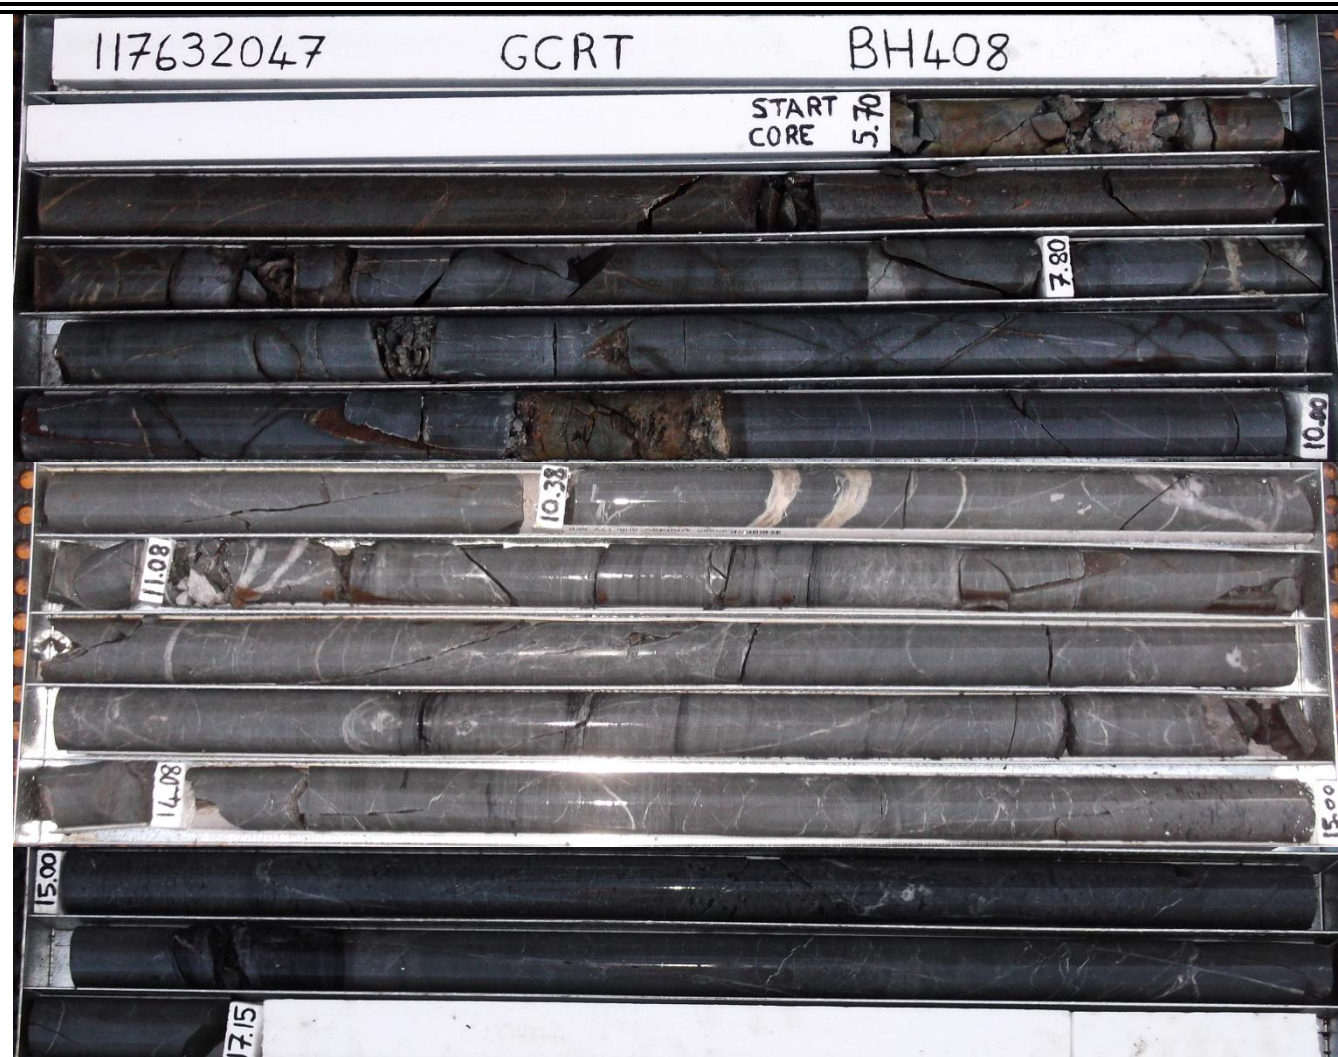
5.70 – 17.15 m

| Drilling | | | | | Field Material Description | | | | Defect Information | | | |
|---|---|---|---|---|---|---|---|---|---|---|--|---|
| NMLC | | 100 | 31 (59) | 10 | | | ARGILLITE<br>fine grained, pale grey, with quartz veining | SW<br>FR | | 8.60 m: J, 70°, Un, Ro, Sn<br>8.70 m: J, 70°, Un, Ro, Sn, incipient<br>8.76 m: J, 70°, Pl, Ro, Sn<br>8.86 m: J, 70°, Pl, Ro, Sn<br>8.92 m: J, 70°, Pl, Ro, Sn<br>8.96 m: J, 50°, Un, Ro, Sn<br>9.00 m: HB<br>9.05 m: J, 80°, Un, Ro, Sn<br>9.10 m: J, 45°, Un, Ro, Sn<br>9.20 m: J, 45°, Un, Ro, Sn<br>9.30 m: J, 10°, Pl, Ro, Sn<br>9.34 m: J, 80°, Un, Ro, Sn<br>9.83 m: J, 45°, Un, Ro, Cn<br>9.98 m: V, 0°<br>10.00 m: DB<br>10.10-10.30 m: J, 80°, Un, Ro, Cn<br>10.55 m: V, 10°, 15 mm, quartz<br>10.60 m: V, 10°, 20 mm<br>10.66 m: DB<br>10.70 m: V, 10°, 3 mm<br>10.85 m: J, 45°, Pl, Ro, Cn<br>10.90 m: V, 80°, 10 mm<br>11.00 m: HB<br>11.05 m: J, 80°, Un, Ro, Cn<br>11.08-11.13 m: DB, recovered non intact possibly due to quartz vein and start of drill run<br>11.20-11.23 m: recovered non intact possible drilling break with quartz<br>11.32 m: J, 45°, Pl, Ro, Cn<br>11.42 m: J, 5°, Pl, Ro, Cn<br>11.54 m: J, 5°, Un, Ro, Ct<br>11.55 m: J, 45°, Pl, Ro, Ct<br>11.60 m: J, 6°, Pl, Ro, Ct<br>11.72 m: J, 5°, Un, Ro, Cn<br>11.74 m: J, 45°, Un, Ro, Ct<br>11.80 m: J, 80°, Ro, Sn-Ct, dark brown<br>11.98 m: J, 80°, Un, Ro, Cn<br>12.00 m: HB<br>12.14 m: J, 80°, Un, Sm, Cn<br>12.30 m: J, 70°, Un, Ro, Ct, 2 mm, quartz<br>12.43-12.50 m: J, 70°, Un, Ro, Ct, quartz<br>12.58 m: J, 5°, Un, Ro, Ct<br>12.80 m: DB<br>13.00 m: HB<br>13.30 m: J, 5°, Un, Ro, Ct<br>13.40 m: J, 60°, Ro, Ct<br>13.43 m: J, 5°, Pl, Ro, Ct<br>13.60 m: V, 80°, 1 mm<br>13.78 m: J, 5°, Pl, Ro, Cn<br>13.82 m: J, 5°, Un, Ro, Ct, 2 mm<br>13.95-14.00 m: HB<br>14.08 m: J, 80°, Un, Ro, Cn<br>14.10 m: J, 45°, Un, Ro, Cn<br>14.18 m: J, 0°, Un, Ro, Cn<br>14.20-14.74 m: J, 85°, Un, Ro, Cn<br>14.63 m: J, Un, Ro, Cn<br>14.85-15.00 m: Un, Ro, Cn<br>15.01 m: HB<br>15.20-15.40 m: V, 70°, Pl<br>15.52 m: J, 35°, Pl, Ro, Cn<br>15.62 m: J, 35°, Pl, Ro, Cn<br>15.90 m: J, 10°, Un, Ro, Cn<br>15.95 m: J, 30°, Pl, Sm, Cn<br>16.30-16.60 m: V, 80°, Un<br>16.95 m: J, 45°, Pl, Ro, Cn | | |
| | | 99 | 61 (71) | 16 | 16.10<br>-19.30 | | to 16.25 m with dark grey banding and associated close fracturing | | | | | |
