# ENGINEERING BORELOG

BOREHOLE No : 137

REFERENCE No : H8090

PROJECT : PACIFIC MOTORWAY LOGAN RIVER SERVICE ROAD BRIDGE FOUNDATION INVESTIGATION  
 LOCATION : Abutment A, Grid ref. 19534E 140139N  
 PROJECT No : MP1006 SURFACE R.L. : 5.39 DRILLER : FOUNDRIL  
 JOB No : DATUM : AHD DATE DRILLED : 05/09/97

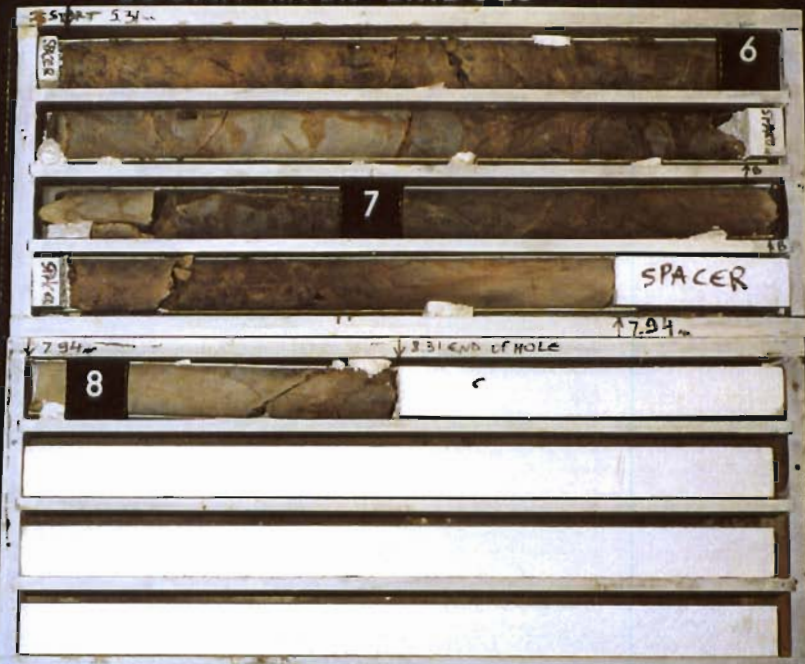
HOLE 137  
START 5.31  
END 8.31

PACIFIC MOTORWAY  
LOGAN RIVER BRIDGES

H 8090  
1 OF 1  
SEP 1997
