**GEOTECHNICAL  
BOREHOLE LOG**

BOREHOLE No **BH277**

PROJECT	Mackay Ring Road			COORDINATES	721230.8 E; 7663250.1 N								
LOCATION	Stage 2 Overpass			PROJECT No	FG6184	SURFACE RL	15.26m	PLUNGE	90°	DATE STARTED	21/09/2015	GRID DATUM	GDA 94 / MGA 255
JOB No	242/10G/906	HEIGHT DATUM	A.H.D.	BEARING	°	DATE COMPLETED	21/09/2015	DRILLER	Saxon Drilling

**CORE PHOTO LOG**

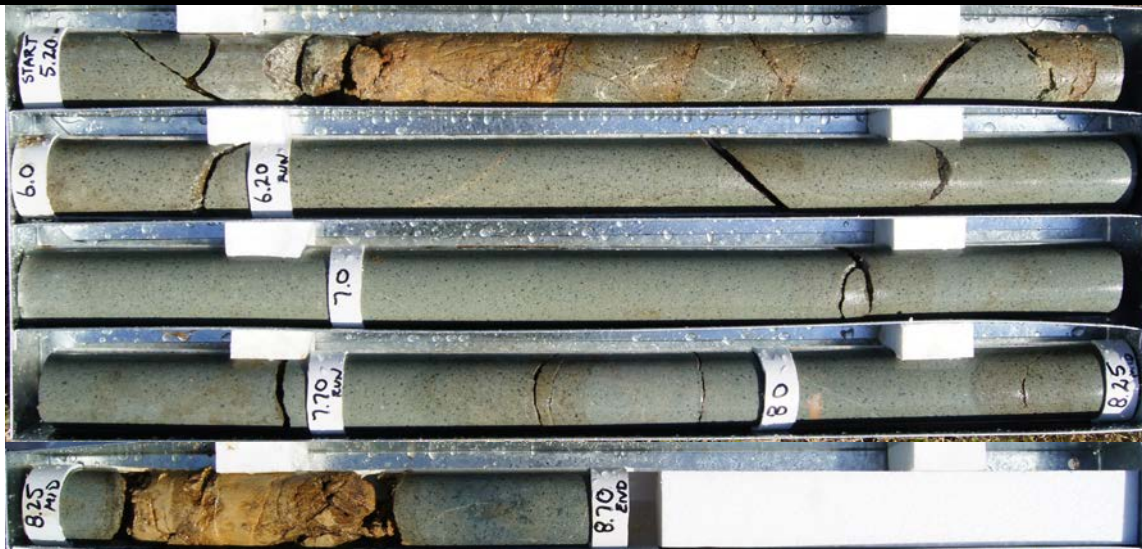
Project Name	<b>Mackay Ring Road Stage 1</b>		
Project No.	FG 6184	Date	21/09/15
Borehole No.	BH 277	TMR H No.	H12429
Location	Port Access Rd Overpass Abutment B	Start Depth (m)	5.20
Detail		Finish Depth (m)	8.70
Chainage		Submitted By	BW
Remarks
