# ENGINEERING BOREHOLE

BOREHOLE No   BH27

PROJECT   GATEWAY BRIDGE DUPLICATION FOUNDATION INVESTIGATION - GATEWAY UPGRADE PROJECT

LOCATION   PIER 15 - DOWN STREAM END   COORDINATES   9920.9 E; 168533.1 N

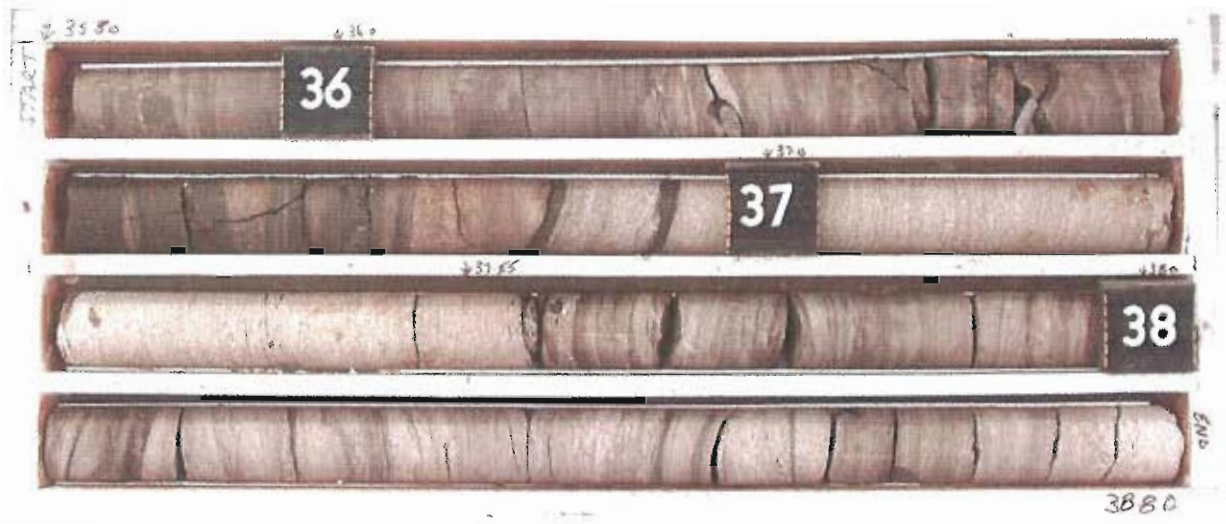
Borehole No: **BH 27**

Project: **Gateway Bridge Duplication Investigation**

Start Depth: 35.80m

Finish Depth: 38.80m

39	-34.95				100	INTERBEDDED SANDSTONE AND MUDSTONE (SANDSTONE DOMINANT) SW : Pale grey to white grey, laminated, medium to high strength Defects - Fragment lamination partings <10° (5-10/m). Borehole terminated at 38.8m		SW											Is(50)=1.22 MPa Is(50)=1.41 MPa Is(50)=2.36 MPa Is(50)=1.95 MPa Is(50)=0.28 MPa Is(50)=0.66 MPa Is(50)=0.46 MPa Is(50)=1.21 MPa	x o x o x o x o
40
