BOREHOLE RECORD

HOLE BH101

PROJECT South West Arterial

CORED BOREHOLE RECORD

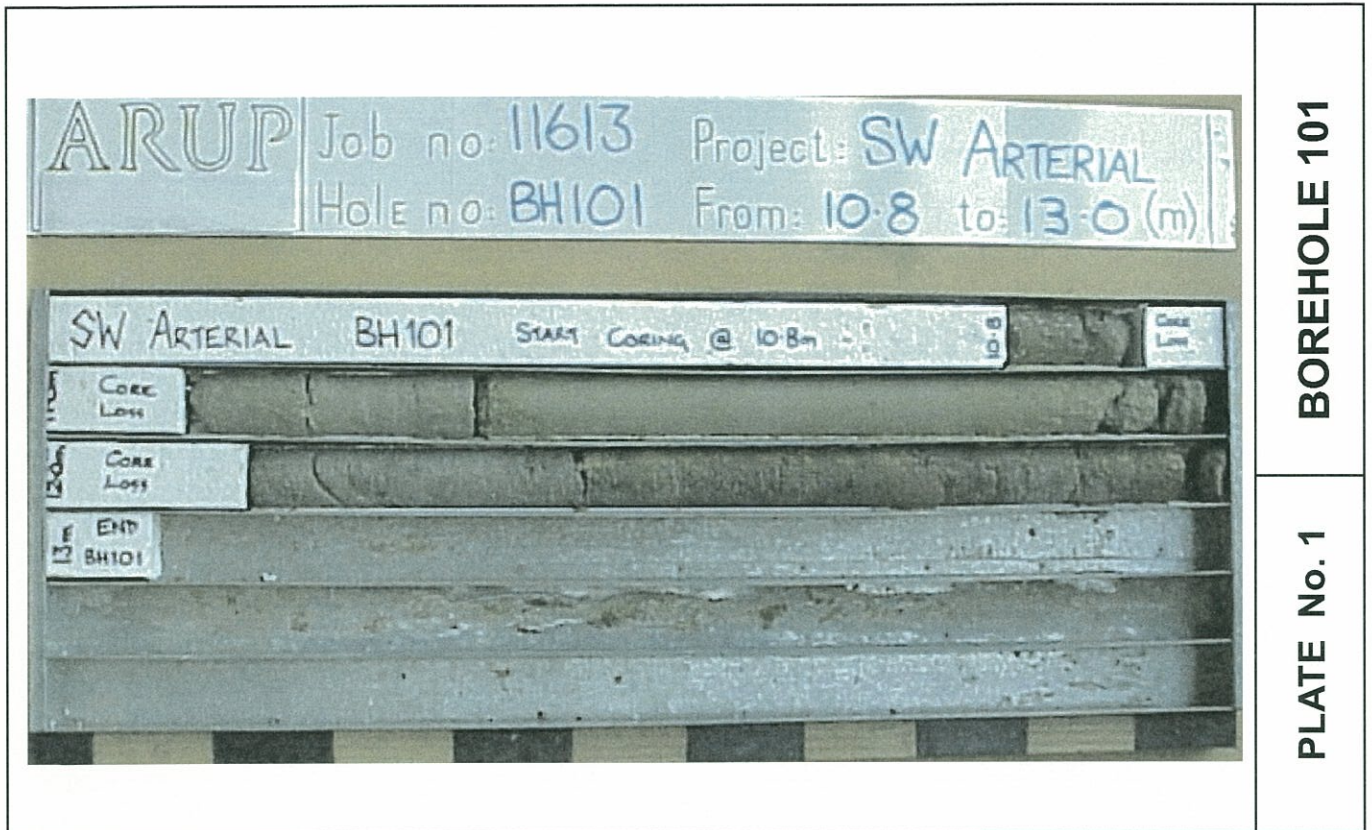
PLATE No. 1

BOREHOLE 101
