ENGINEERING BOREHOLE LOG

BOREHOLE No BH171
SHEET 2 of 3
REFERENCE No 12112

PROJECT Mackay Ring Road Geotechnical Investigation - Stage 1
LOCATION Fursden Creek Overflow Bridge Abutment A; CH: 8690m; COORDINATES 721429.5 E; 7661010.6 N
PROJECT No FG6184 SURFACE R.L. 7.60m PLUNGE DATE STARTED 21/10/14 GRID DATUM GDA 94 /MGA Zone 55
JOB No HEIGHT DATUM AHD BEARING DATE COMPLETED 22/10/14 DRILLER Saxon Drilling

CORE PHOTO LOG

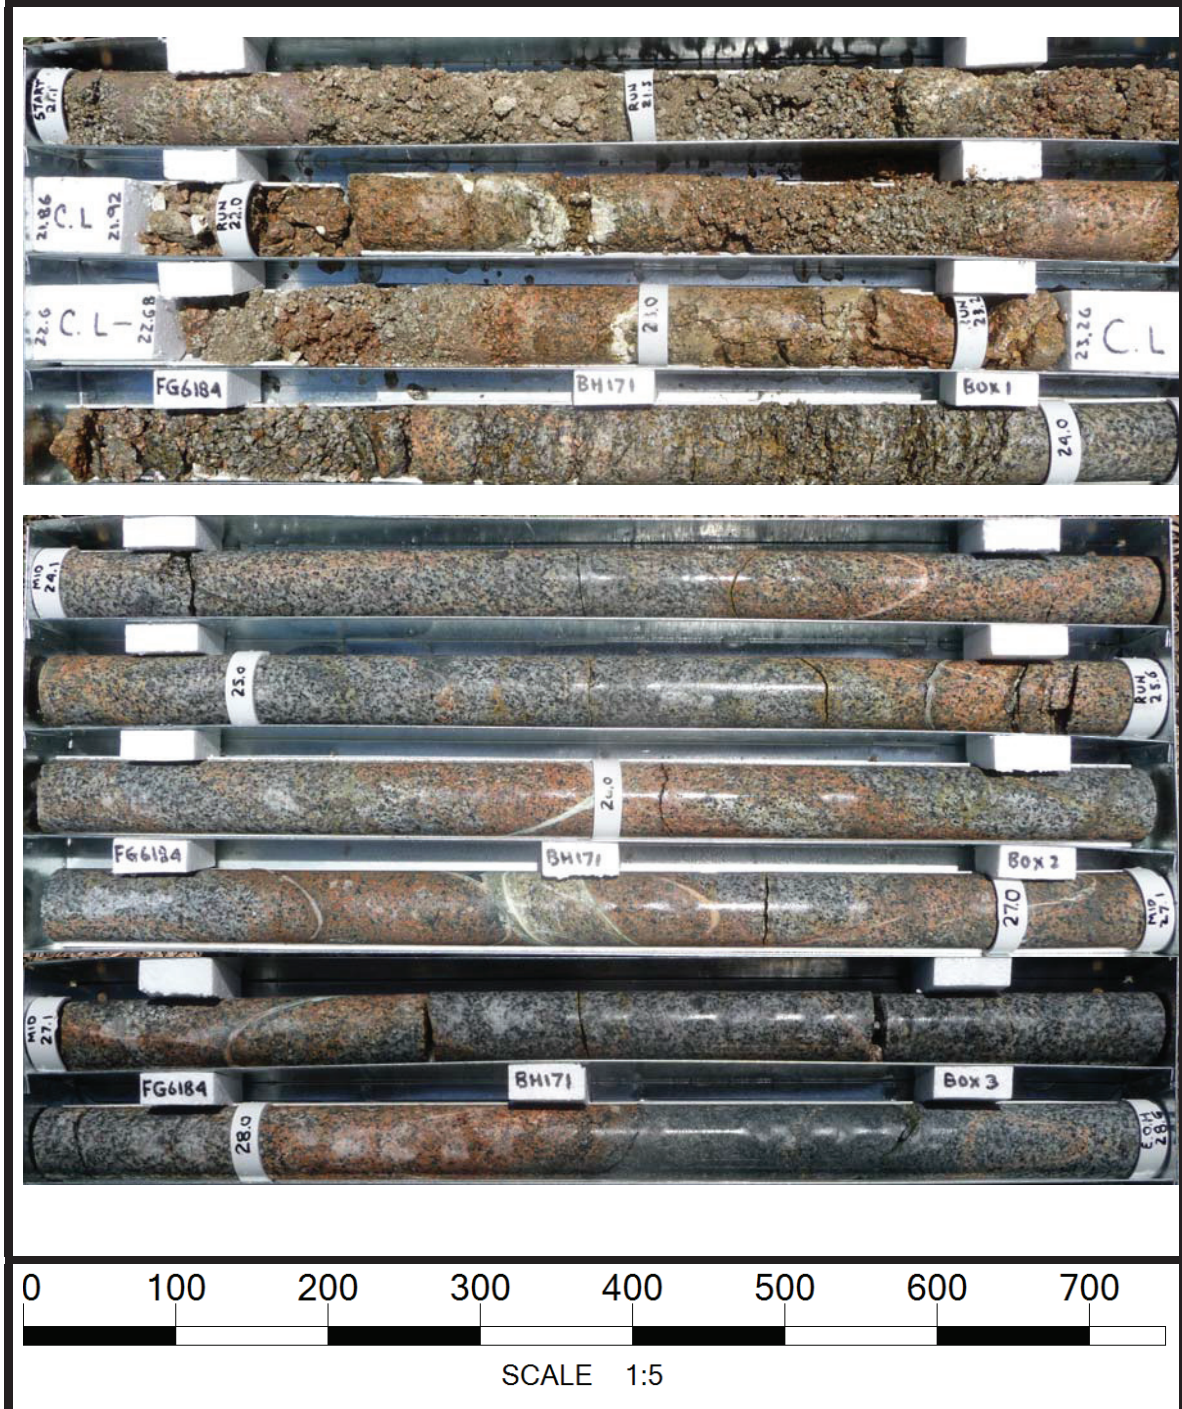
Project Name	Mackay – Ring Road		
Project No	FG6184	Date	22/10/14
Borehole No	BH171	TMR H No	12112
Location	Fursden Creek Overflow Bridge	Start Depth (m)	21.1
Detail	Abutment A	Finish Depth (m)	28.6
Chainage	8690m	Submitted By	J. Lopez
Remarks

DEPTH (m)	R.L. (m)	AUGER CASING WASH BORING CORE DRILLING	RQD (%) CORE REC %	SAMPLE	MATERIAL DESCRIPTION	LITHOLOGY	WEATHERING											GRAPHIC LOG	ADDITIONAL DATA AND TEST RESULTS	SAMPLES TESTS		
							USC	EH	VH	H	M	J	VL	EL	EC	VC	W				VW	EW
20	-12.40			V	GRANODIORITE (Kgwu) XW: (Cont'd)	+																
21	-13.50			W	GRANODIORITE (Kgwu) HW: Grey, white and pink, fine to coarse grained, massive, very low to low strength.	+																30/140 SPT
22			(0)			+																
			100			+

(0)			+																
22			88			+																21.86m-21.92m: Core Loss
			(0)			+																
			100			+																22.60m-22.68m: Core Loss

(0)			+																
23			87			+																
			60			+																
23.35	-15.75		(0)		GRANODIORITE (Kgwu) MW: Grey, white and pink, fine to coarse grained, massive, medium strength. Highly fractured rock.	+																23.26m-23.30m: Core Loss 23.30m-23.35m: Core Loss

(22)			+																Is(50) = 0.39MPa A (23.60m)
24	-16.40				GRANODIORITE (Kgwu) SW: Grey, white and pink, fine to coarse grained, massive, very high strength. Defects: - Js; 0°-10° (1/m); Pl/Ro, OP, Cn; - Js; 30° (1/m); Pl/Ro, OP, Cn; - Js; 40°-45° (1/m); Pl/Ro, OP, Cn;	+																Is(50) = 5.52MPa D (24.05m)
			94			+																UCS=107MPa Is(50) = 7.00MPa A (24.40m)
