ENGINEERING BOREHOLE LOG

BOREHOLE No BH001

PROJECT BRUCE HIGHWAY (COOROY - CURRA) SECTION A GEOTECHNICAL INVESTIGATION

Project: **Bruce Highway Upgrade (Cooroy – Curra) Section A**

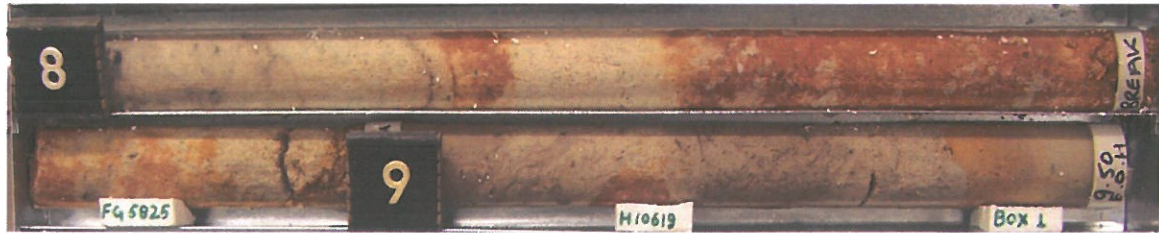
Borehole No: **BH 1**

8.0				H							11,23,20 N=43	SPT	
8.5			(52)		SANDSTONE (HW): Pale grey with orange mottling, fine to coarse grained, bedded.								
9.0					Defects widely spaced.						Is(50) = 0.02MPa	o

9.2					Defects generally dip at 35-40°.						Band of high strength ferricrete		
9.4			100		Defect surfaces are typically clean.						Is(50) = 0.07MPa	x

9.5					9.4 - 9.5m: XW Siltstone bed.	X X							
9.5					Borehole terminated at 9.5m

Start Depth: 8.00m

Finish Depth: 9.50m
