Report No. MGPM06/CPT7/Q151A

# QUEENSLAND TRANSPORT

Operator : Peter Reynolds      CPT Date : 17/01/96 1: 43      Sounding : CPT7      Pg 1 / 1  
 Location : PACIFIC HWY UPGR      Cone Used : MACSIL ELECTRIC      Project No : MGPM06

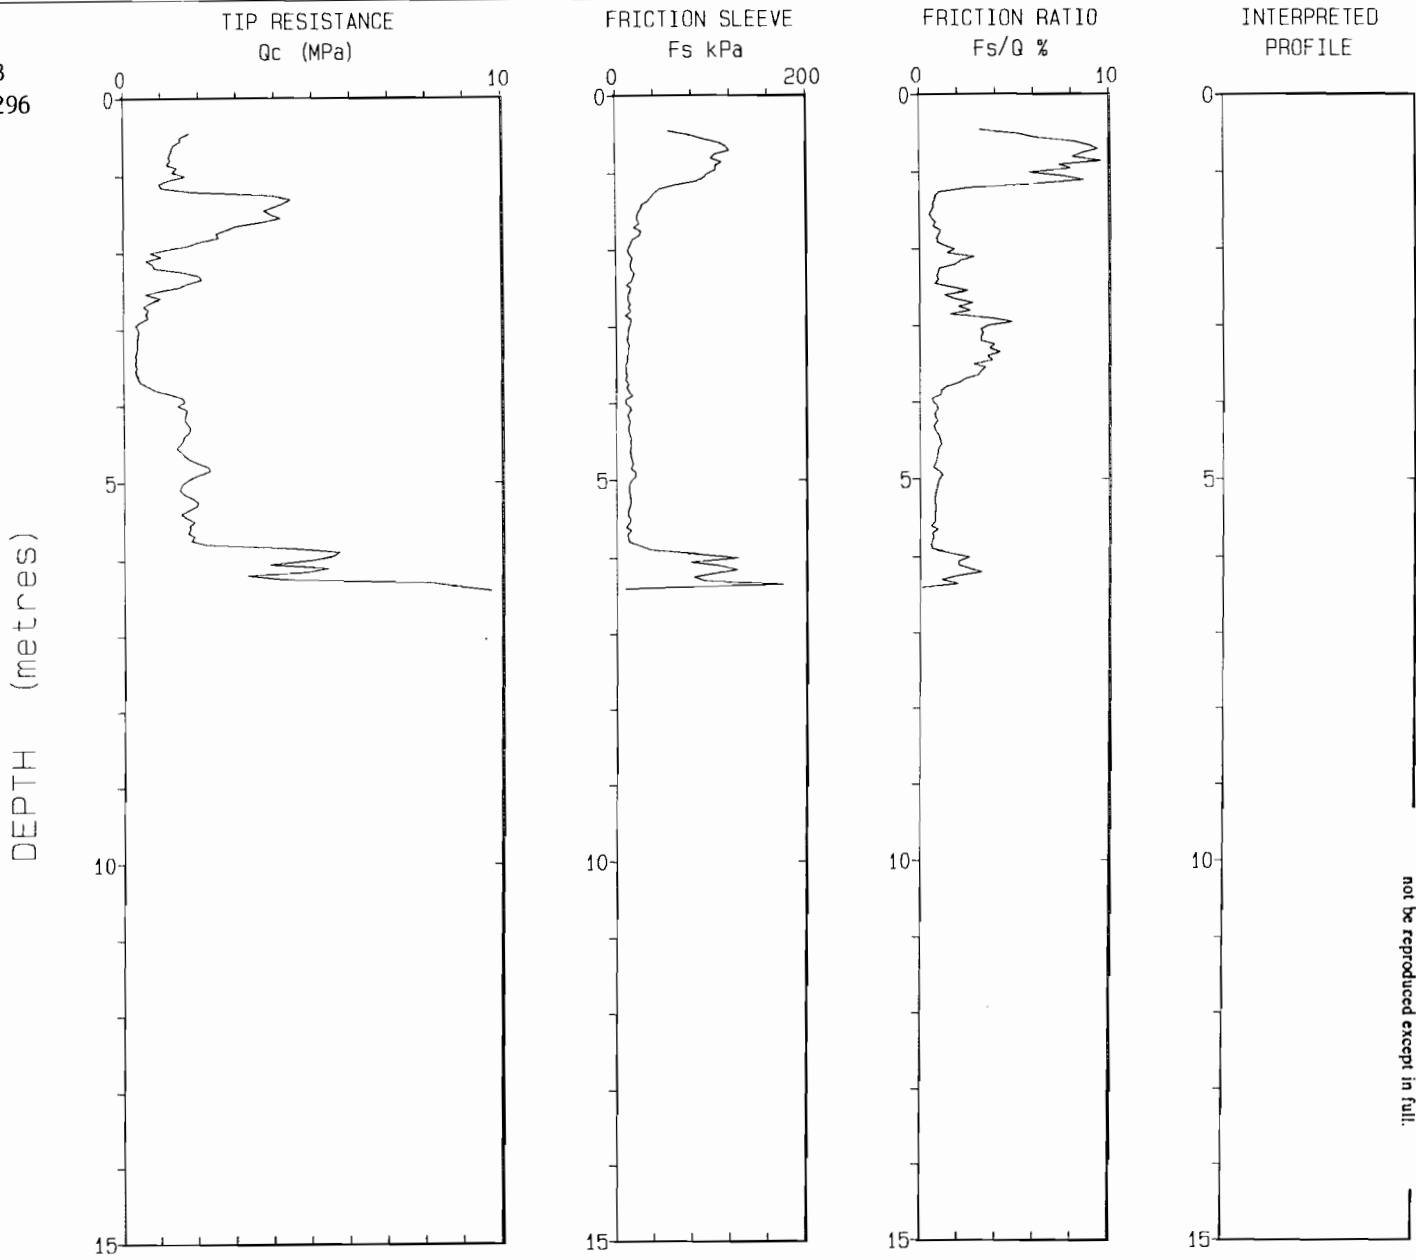
Easting: 31378.303  
 Northing: 119559.296  
 RL: 2.521
