# REPORT OF BOREHOLE: BH2D14

PROJECT: Gold Coast Rapid Transit SURFACE RL: 16.74 m DATUM: AHD

LOCATION: Zone 2 INCLINATION: -90°

## REPORT OF CORE PHOTOGRAPHS: BH2D14

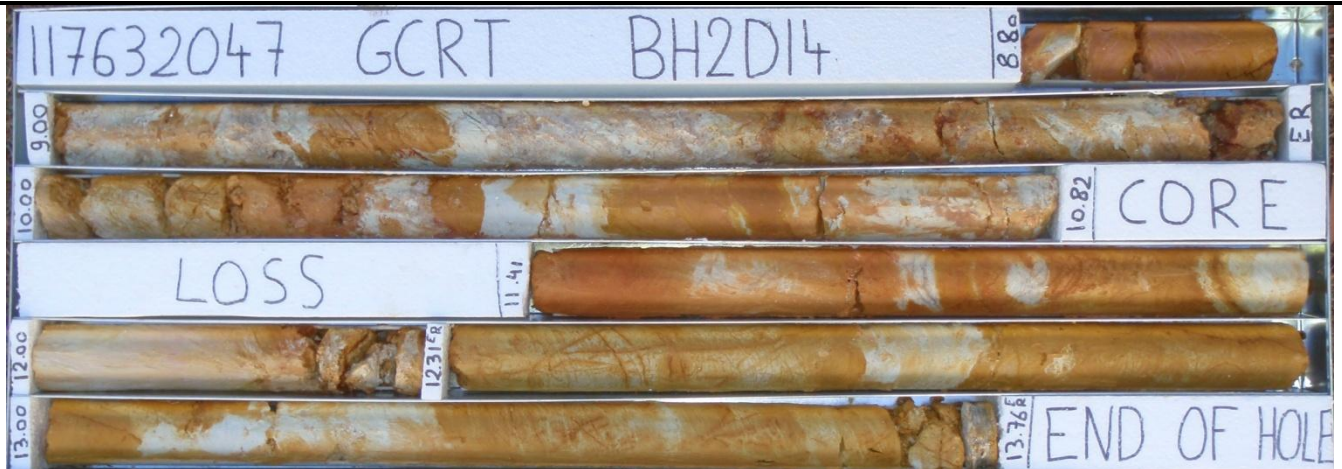
DEPTH RANGE: 8.80 – 13.76 m  
DRILL RIG: FD500  
DRILLER: Foundril Pty Ltd  
LOGGED: FHH DATE: 12/08/11  
CHECKED: NK DATE: 26/9/11

| Drilling | | | | | Field Material Description | | | | | Defect Information | | | | | | | | |
|---|---|---|---|---|---|---|---|---|---|---|--|--|---|---|---|---|---|---|
| | | | | 9 | 8.80<br>7.94<br>9.00<br>7.74<br>9.36<br>7.38 | | Continuation of Sheet 1<br>MUDSTONE<br>fine grained, pale grey and orange brown, pale yellow red in places, bedding parting dipping at 40°, in places with fragments of pale grey chert / quartz / in vein like structures dipping at 20-40°<br>grading to residual soil between 9.0 m and 9.2 m depth<br>grading to residual soil between 9.36 and 9.58 m depth | EW<br>DW<br>DW<br>EW<br>DW | | 8.82 m: J, 60°, Pl, Sm<br>8.90: fracture frequency not relevant as rock is extremely weathered | | | | | | | | |

| Drilling | | | | | Field Material Description | | | | | Defect Information | | | | | | | | | | | |
|---|---|---|---|---|---|---|---|---|---|---|--|--|---|---|---|---|---|---|--|--|--|
| NMLC | Groundwater not encountered | 58 | 0 | 10 | 10.16 | | MUDSTONE | EW | | 10.63 m: J, 20°, Pl, Sm | | | | | | | | | | | |
