# **ENGINEERING BOREHOLE LOG**

BOREHOLE No	BH137
SHEET	<u>1</u> of <u>2</u>
REFERENCE No	<u>H10896</u>

PR	OJECT	WALKERSTON BYPASS PROJECT GEOTECHNICAL INVESTIGATION - BERGMANS ROAD OVERPASS									
LO	CATION	ON _Abutment B - LHS (Ch.74538.2, 1.7m L of Control Line) COORDINATES _711796.1 E; 7655							ORDINATES 711796.1 E; 7655449.	1 N	
PR	OJECT No	_ <u>FG</u> 5	635		SURFACE R.L. <u>33.37m</u> PLUNGE <u>-90</u> °		DATE ST	ARTED _	<u>15/11</u>	/10 GRID DATUM	
JO	B No	<u>242</u>	<u>/33B/6</u>		HEIGHT DATUM <u>AHD</u> BEARING		DATE COMP	PLETED -	<u>15/11</u>	/10 DRILLER <u>Cairns</u> Drilling	1
DEPTH (m)		UGER ASING VASH BORING	-	SAMPLE	MATERIAL DESCRIPTION	USC WEATHERING	STRENGTH S 표풍ェェン의 영	DEFECT SPACING (mm)	GRAPHIC LOG	ADDITIONAL DATA AND TEST RESULTS	SAMPLES TESTS
0	33.37	40≤C	S REC %	S	Silty SAND (RESIDUAL)	≥≤			0		∞ ⊢

#### Project: Walkerston Bypass (Bergmans Road)

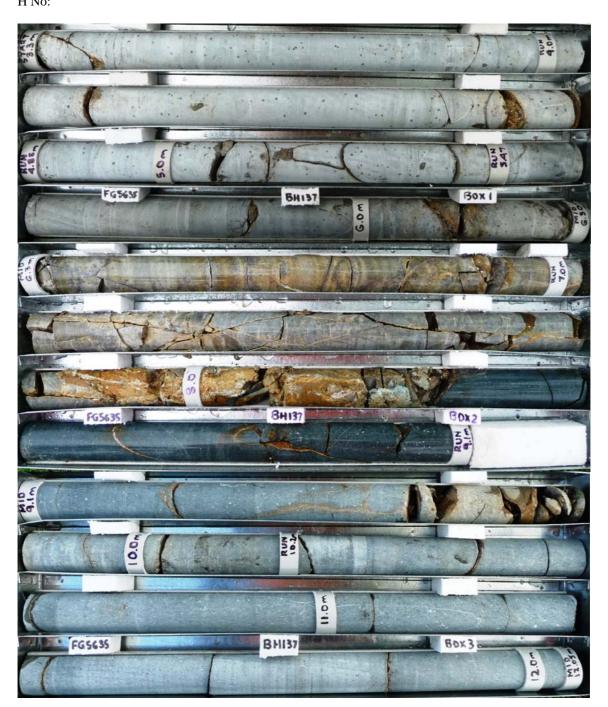
Borehole No: BH137 Start Depth: Finish Depth: Project No: H No:

3.30 m 15.00 m FG5635

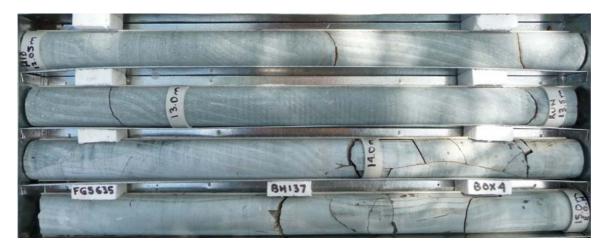
#### Project: Walkerston Bypass (Bergmans Road)

Borehole No: BH137 Start Depth: Finish Depth: Project No: H No:

3.30 m 15.00 m FG5635
