**BOREHOLE ENGINEERING LOG****HOLE NO : CURVE 59_BH01**

PROJECT : SAFER ROADS SOONER PROJECT

LOCATION : KENNEDY HWY (CAIRNS - MAREEBA)

Client: Transport and Main Roads	
		Project: Safer Road Sooner	
drawn	AJ	Core Photograph – Curve 59_BH01	
date	14/08/2013	Project no. CB24735.01	
scale	NTS	Photo No: Curve 59_BH01	1 of 1

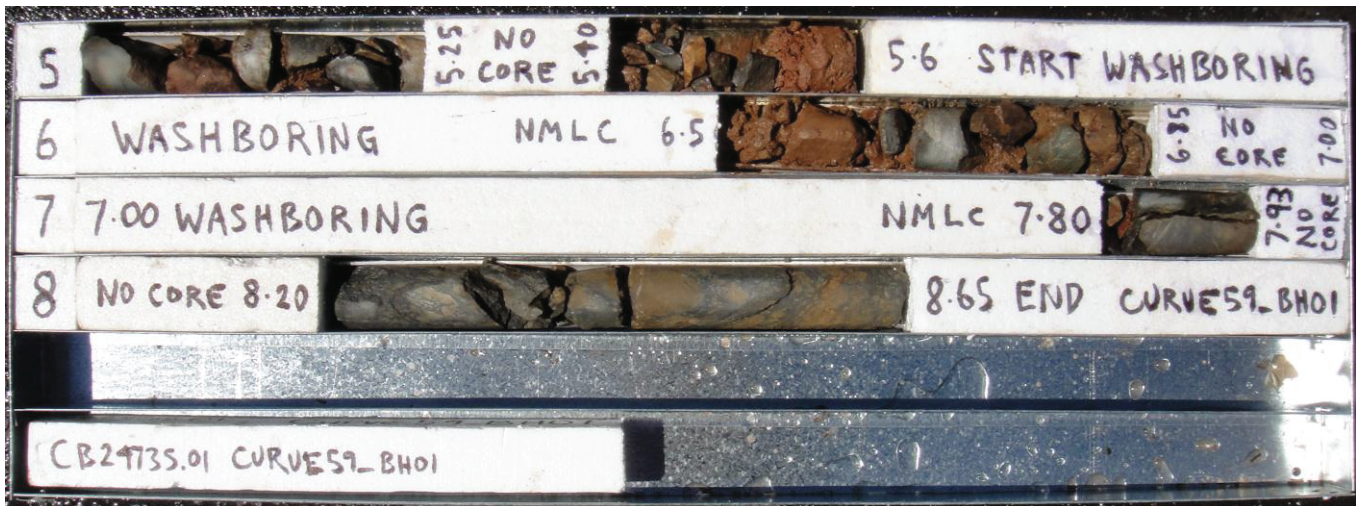
DRILLING		MATERIAL				DEFECTS & COMMENTS		GENERAL			
DRILLING	WATER DETAIL	TCR/ROD	RL (m)	DEPTH (m)	GRAPHIC LOG	DESCRIPTION ROCK TYPE : Colour, Grain size, Structure (texture, fabric, mineral composition, hardness alteration, cementation, etc as applicable)	Weathering	ESTIMATED STRENGTH Is(50)	DEFECT SPACING (mm)	Description of joints, seams, defects, additional observations and comments	GENERAL
WB			312.5	6.0		QUARTZITE: Brown, dark grey appears as SILTY CLAY (CI), medium plasticity, trace of fine to coarse grained sand and medium grained angular gravel, very stiff to hard. <i>(continued)</i>	EW - HW				
NMLC		70% TCR 0% ROD 7.00				QUARTZITE: Grey, grey brown, indistinct foliation.	EW - HW			6.55 JT 30° IR RF 6.57 JT 90° IR RF 6.61 JT 50° IR RF 6.62 JT 5° IR RF 6.65 JT 20° IR RF 6.70 JT 50° CH IR RF 6.73 JT 70° IR RF 6.74 JT 0° ST RF 6.78 JT 30° IR RF	
WB			311.5	7.0		QUARTZITE: Red brown, dark grey appears as SANDY CLAY (CI), medium plasticity, very stiff. CORE LOSS 0.15m (6.85-7.00)	EW

NMLC		33% TCR 0% ROD 8.20				QUARTZITE: Brown, dark grey appears as SANDY CLAY (CI), medium plasticity, fine to coarse grained sand, trace of medium grained angular gravel, hard.	MW			7.82 JT 0 - 5° IR VR 7.86 JT 90° IR VR 7.88 JT 80° IR VR	
NMLC		100% TCR 0% ROD 8.65				QUARTZITE: Grey, pale grey, indistinct to distinct foliation at 40° to 60°. CORE LOSS 0.27m (7.93-8.20)	MW			8.20 JT 5° IR VR 8.27 JT 90° IR VR 8.32 JT 40 - 90° IR VR 8.38 JT 0° IR VR 8.43 JT 0° ST VR 8.52 JT 20° IR RF 8.54 JT 90° IR VR 8.64 JT 0 - 5° IR VR	
						End of Cored Drill Hole at 8.65 m
