# CONE PENETROMETER TEST RESULT

Client : McConnell Consulting  
Project : Queensland Cotton  
Location : Hemmant

Test No : **QC-11**

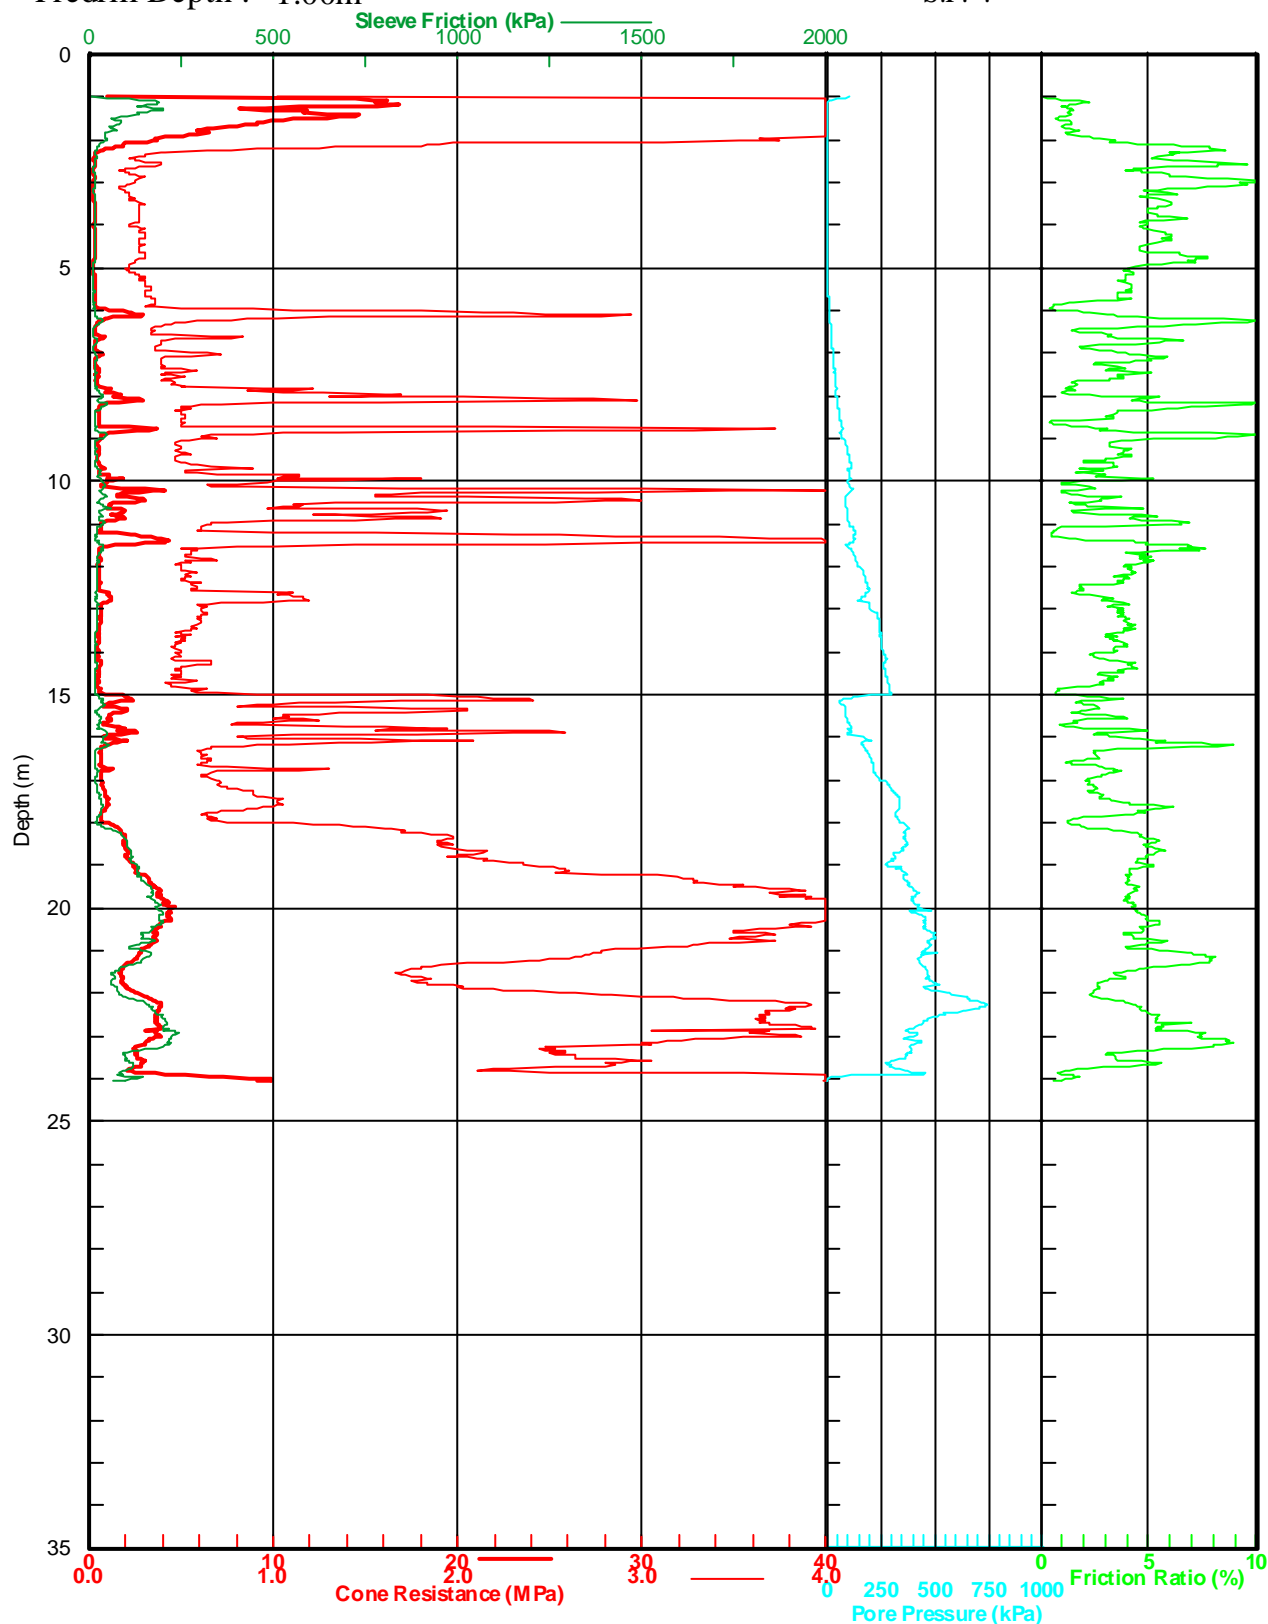
DGPS Position : 56J 0513090, 6965337 (AMG84)

Predrill Depth : 1.00m

Tested in accordance with AS 1289.6.5.1 -1999.
