# ENGINEERING BORELOG

BOREHOLE No : 143  
 SHEET : 1 OF 1  
 REFERENCE No : H8096

PROJECT : PACIFIC MOTORWAY LOGAN RIVER SERVICE ROAD BRIDGE FOUNDATION INVESTIGATION  
 LOCATION : Pier 4 grid ref 19578.5E 140050N  
 PROJECT No : MP1006 SURFACE R.L. : -5.80 DRILLER : R & D DRILLING  
 JOB No : DATUM : AHD DATE DRILLED :

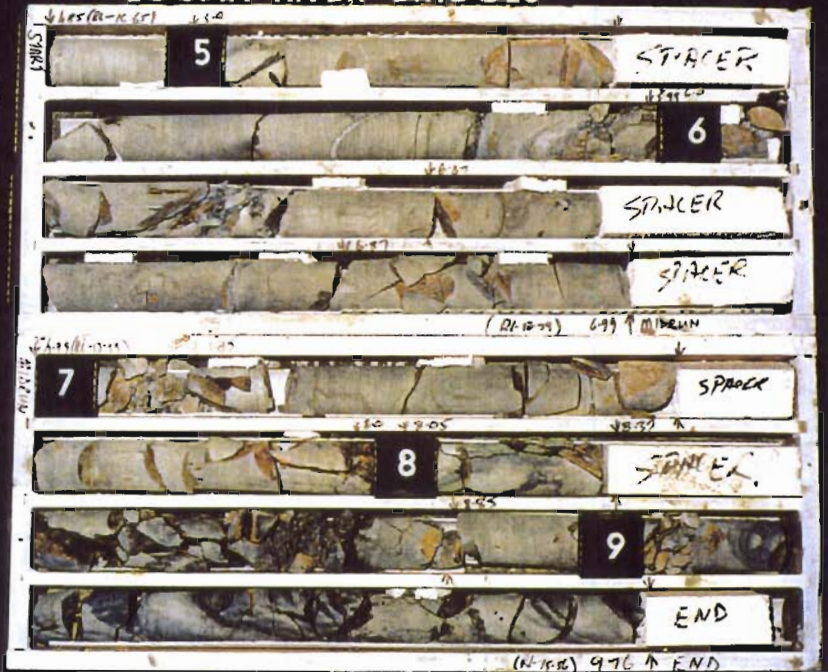
HOLE 143  
START 4.85  
END 9.76

PACIFIC MOTORWAY  
LOGAN RIVER BRIDGES

H 8096  
1 OF 1  
SEP 1997
