SOIL SURVEYS 00:LIBRARY 2012:05:G.LB Log SOIL SURVEY BOREHOLE LOG 111-12936 NEW.GPJ <<DrawingFiles>> 21/05/2012 14:32 8.30.002 Developed by Dargel

AECOM  
Brisbane  
Cross River Rail  
Core Photo - BH 314

**PROJECT:** **CRR**  
**PROJECT No.:** **110-12936**

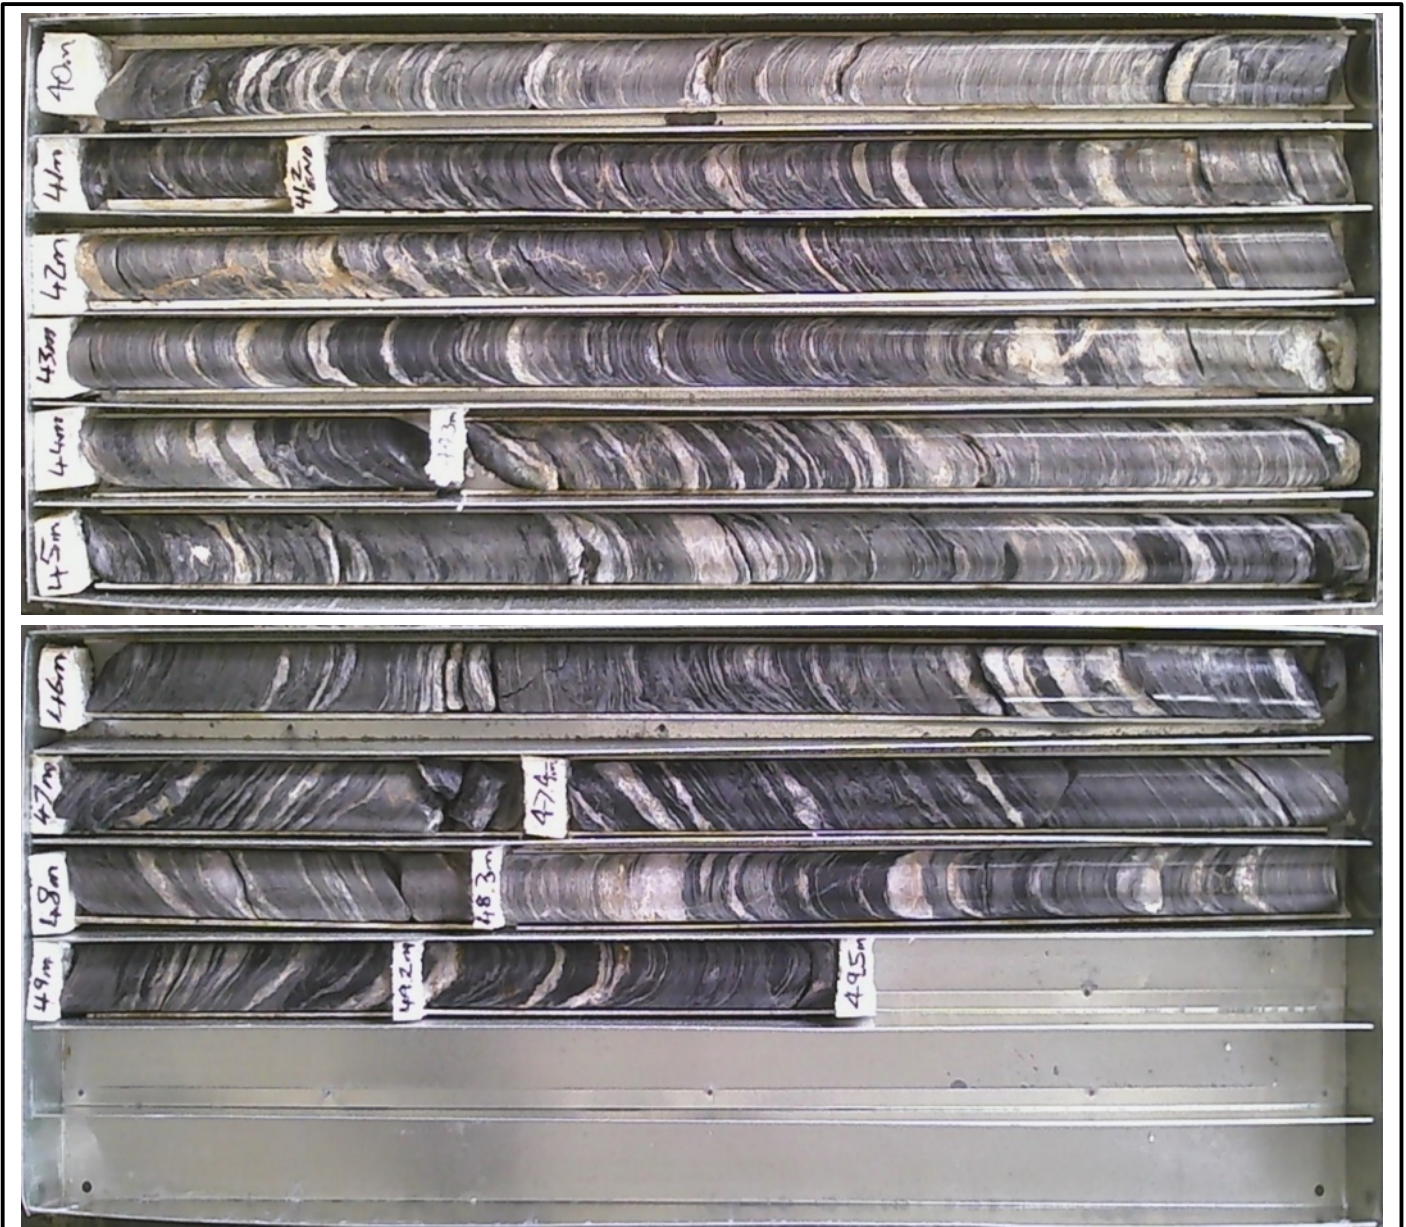
DRAWN	DT	DATE	26/04/2012
CHECKED	CB	DATE	26/04/2012
SCALE	Not To Scale		A4
PROJECT No	110-12936	FIGURE No	2/2

**AECOM**  
**Brisbane**  
**Cross River Rail**  
**Core Photo - BH 314**
