# ENGINEERING BORELOG

PROJECT : PACIFIC MOTORWAY LOGAN RIVER SERVICE ROAD BRIDGE FOUNDATION INVESTIGATION  
 LOCATION : Pier 4 grid ref 19581E 140050N  
 PROJECT No : MP1006 SURFACE R.L. : -5.61 DRILLER : R & D DRILLING  
 JOB No : \_\_\_\_\_ DATUM : AHD DATE DRILLED : \_\_\_\_\_

PACIFIC MOTORWAY  
LOGAN RIVER BRIDGES

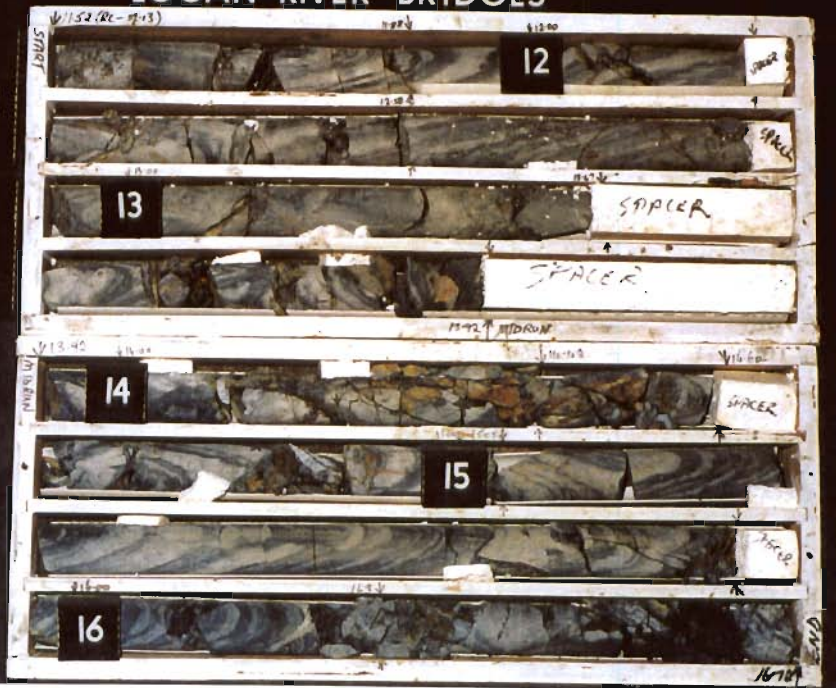
HOLE 142  
START 11.52  
END 16.72

H 8095  
1 OF 1  
SEP 1997

MP1006
