CONE PENETROMETER TEST RESULT

Client : McConnell Geoservices
Project : Oxlade Drive
Location : 85 Oxlade Drive, New Farm, Qld

Test No : **MG-OD-C02**

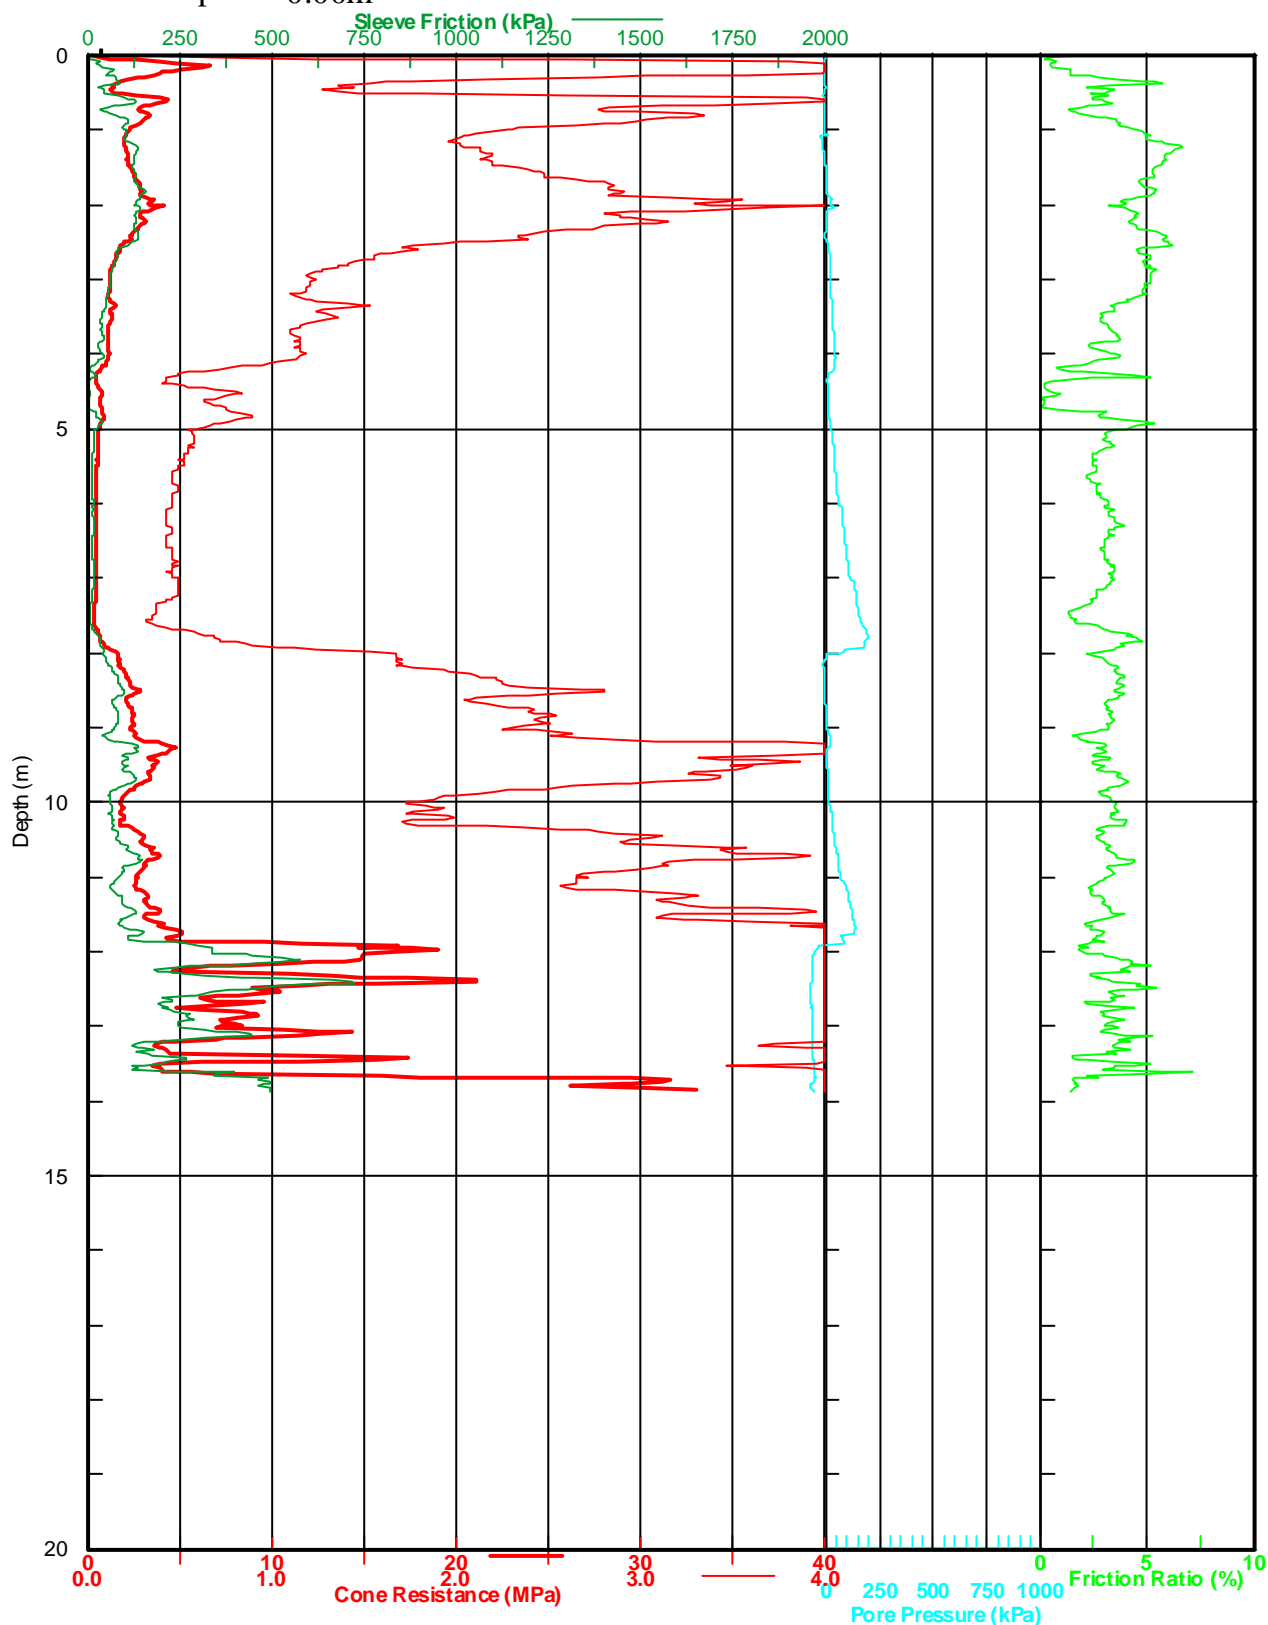
DGPS Position : 56J 0504558, 6960901 (AMG '84)
Predrill Depth : 0.00m

Tested in accordance with AS 1289.6.5.1 -1999.
