ENGINEERING BOREHOLE LOG

BOREHOLE No BH109
SHEET 1 of 5
REFERENCE No 11468

PROJECT Townsville Ring Road Section 4
LOCATION Kalynda Parade Overpass COORDINATES 467781.4 E; 7866516.7 N
PROJECT No FG6020 SURFACE R.L. 13.90m PLUNGE DATE STARTED 12/3/13 GRID DATUM GDA 94
JOB No 268/10M/5 HEIGHT DATUM AHD BEARING DATE COMPLETED 14/3/13 DRILLER Cairns Drilling

CORE PHOTO LOG

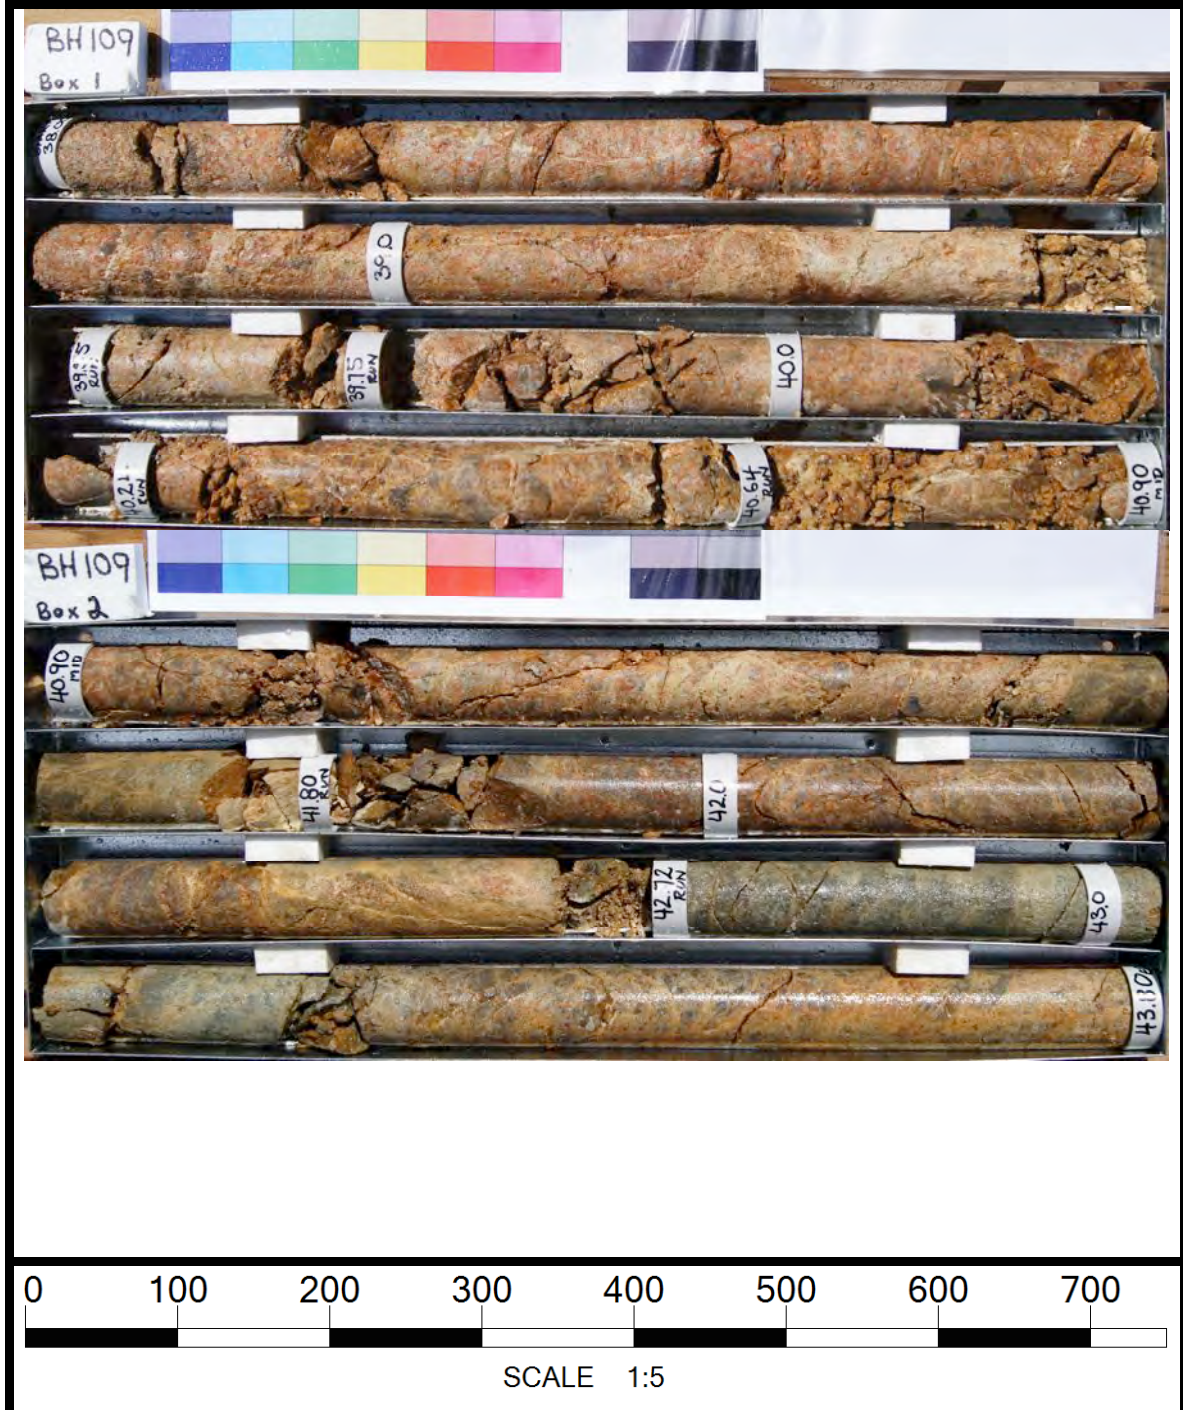
38	-24.10			(19)		MW: Orange, pale grey, pale brown, medium to coarse grained, massive, low to medium strength. Defects: -Joints at 30° (1/m) -Joints at 40° (2/m) -Joints at 50°-60° (5/m) -Joints at 70°-80° (7/m) -Irregular joints (7/m) Defects are generally medium spaced, planar or irregular, rough, open, weathered and clay coated.											Is(50) = 0.26MPa	o
39								MW									HW Zone: Pale grey, pale orange, very low to low strength.	
40				100 (0) 100 (0) (0)													Is(50) = 0.27MPa	o

DEPTH (m)	R.L. (m)	AUGER CASING WASH BORING CORE DRILLING	RQD (%)	CORE REC %	SAMPLE	MATERIAL DESCRIPTION	LITHOLOGY	USC WEATHERING	INTACT STRENGTH						DEFECT SPACING (mm)	GRAPHIC LOG	ADDITIONAL DATA AND TEST RESULTS	SAMPLES TESTS
									EH	VH	H	M	J	VL				
40	-26.10					GRANITE MW (Cont'd): Some HW low strength zones along joints.												
			100	(0)														
			100	(13)														
41																		
	-27.90		100	(11)													Is(50) = 0.49MPa	o
42	-28.40					SW: Pale grey / orange, medium to coarse grained, massive, high strength. Defects: -Joints at 20° (1/m) -Joints at 35° (1/m) -Joints at 45° (3/m)												
			100	(33)		Defects are mainly medium spaced and generally planar, rough, open and iron stained.												
43						MW: Brown / pale grey / pale orange, medium to coarse grained, massive, generally medium strength. Defects:												
	-29.90		100			-Joints at 15° (1/m) -Joints at 40° (4/m) -Joints at 60°-70° (1/m) -Irregular joints (3/m) Defects are mainly medium spaced, and generally planar to irregular, rough, open, iron stained and weathered.

Project Name	Townsville Ring Road Section 4		
Project No	FG 6020	Date	14/03/13
Borehole No	BH 109	TMR H No	11468
Location	Kalynda Parade Overpass	Start Depth (m)	38.00
Detail	Abutment B (Right)	Finish Depth (m)	43.80
Chainage		Submitted By	BW
Remarks
