# REPORT OF BOREHOLE: BH220

PROJECT: Gold Coast Rapid Transit SURFACE RL: 24.26 m DATUM: AHD

LOCATION: Zone 2 INCLINATION: -90°

JOB NO: 117632047 HOLE DEPTH: 32.90 m

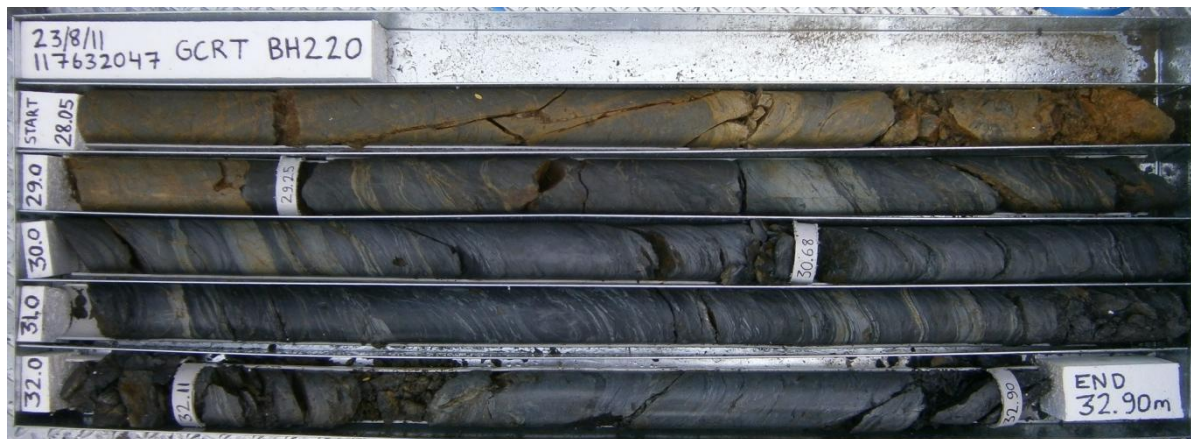
## REPORT OF PHOTOGRAPHS: BH220

DEPTH RANGE: 28.05 – 32.90 m  
DRILL RIG: FD500  
DRILLER: Foundril Pty Ltd  
LOGGED: CA DATE: 24/8/11  
CHECKED: NK DATE: 26/9/11

| Drilling | | | | | Field Material Description | | | | | Defect Information | | | | |
|---|---|---|---|---|---|---|---|---|--|---|--|---|--|--|
| | | | | 30 | | ARGILLACEOUS MUDSTONE<br>fine grained, grey with orange brown staining, foliated at 50° | SW | | | 29.94 m: X, 50°, Pl, Sm, Sn, FeO<br>30.04 m: X, 50°, Pl, Sm, Sn, FeO<br>30.31 m: J, 70°, Un, Sm, Cn<br>30.54 m: X, 60°, Pl-Un, Sm, Cn-Sn, FeO<br>30.60 m: X, 60°, Pl, Sm, Cn<br>30.77 m: X, 50°, Pl, Sm, Cn<br>30.79 m: X, 50°, Pl, Sm, Sn, FeO<br>30.85 m: X, 50°, Pl, Sm, Sn, FeO<br>30.90 m: X, 50°, Pl, Sm, Cn<br>30.94 m: X, 50°, Pl, Sm, Cn<br>31.00 m: X, Pl, Sm, Sn, FeO<br>31.05 m: X, 50°, Pl, Sm, Sn, FeO<br>31.18 m: X, 40°, Pl, Sm, Sn, FeO<br>31.22 m: X, 40°, Pl, Sm, Sn, FeO<br>31.57 m: X, 40°, Un, Sm, Cn<br>31.60 m: X, 50°, Un, Ro, Sn, FeO<br>31.67 m: X, Pl, Sm, Cn<br>31.87 m: J, 60°, Un, Sm, Ct, clay and EL strength platy rock fragments<br>31.95 m: J, 60°, Un, Sm, Ct, EL strength platy rock fragments, iron stained<br>32.14 m: X, 60°, Pl, Sm, Sn, FeO<br>32.16 m: X, 50°, Pl, Sm, Sn, FeO<br>32.18 m: X, 50°, Pl, Sm, Cn<br>32.22 m: X, 40°, Un, Sm, Cn, FeO<br>32.25-32.40 m: CZ, 60°, Un, Sm, Sn, FeO, fine to medium gravel sized rock fragments<br>32.56 m: X, 50°, Pl, Sm, Sn, FeO<br>32.57-32.75 m: 90°, Un, Ro, Sn, FeO<br>32.73 m: X, 60°, Pl, Sm, Ct, VL strength platy rock fragments<br>32.87 m: X, 60°, Un, Sm, Cn | | | | |
