ENGINEERING BOREHOLE LOG

BOREHOLE No	<u>BH170</u>
SHEET	<u>1</u> of <u>3</u>
REFERENCE No	<u>12111</u>

PROJECT Mackay Ring Road Geotechnical Investigation - Stage 1
LOCATION Fursden Creek Overflow Bridge Abutment A; CH: 8691m; COORDINATES 721415.3 E; 7661013.3 N
PROJECT No FG6184 SURFACE R.L. 7.32m PLUNGE _____ DATE STARTED 21/10/14 GRID DATUM GDA 94 /MGA Zone 55
JOB No _____ HEIGHT DATUM AHD BEARING _____ DATE COMPLETED 22/10/14 DRILLER Saxon Drilling

CORE PHOTO LOG

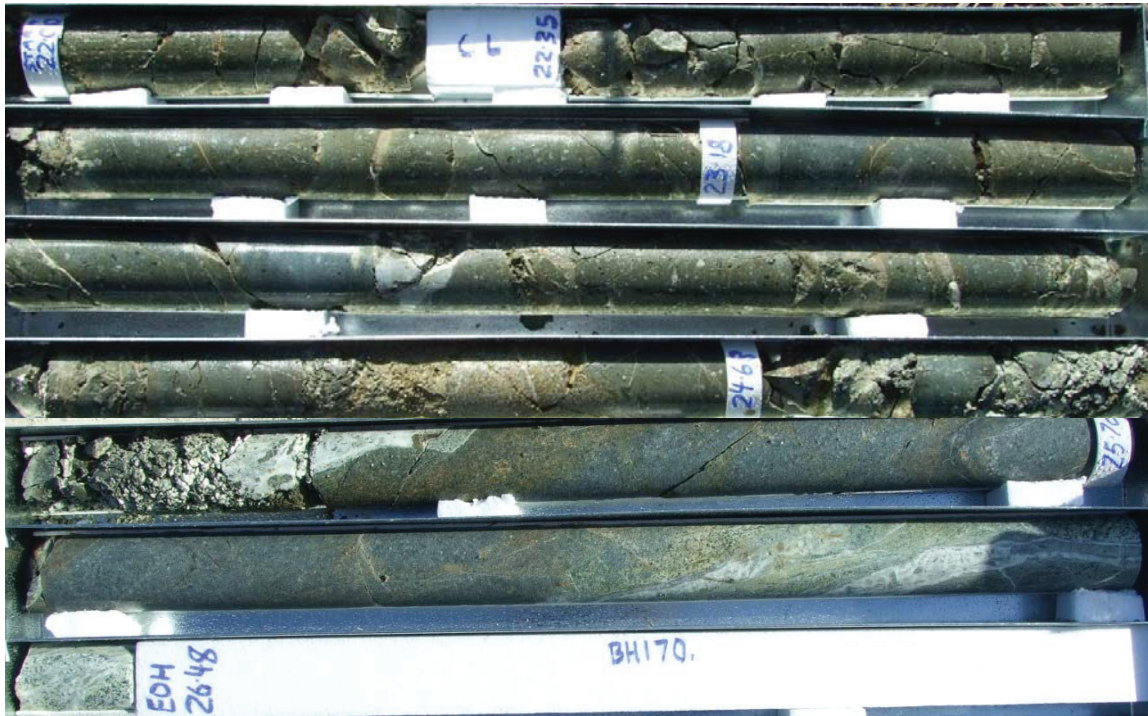
Project Name	Mackay – Ring Road		
Project No	FG6184	Date	22/10/14
Borehole No	BH170	TMR H No	12111
Location	Fursden Creek Overflow Bridge	Start Depth (m)	22.0
Detail	Abutment A	Finish Depth (m)	26.48
Chainage	8691m	Submitted By	M.Ensor
Remarks

DEPTH (m)	R.L. (m)	AUGER CASING WASH BORING CORE DRILLING	RQD (%)	CORE REC %	SAMPLE	MATERIAL DESCRIPTION	LITHOLOGY	USC	WEATHERING											DEFECT SPACING (mm)	GRAPHIC LOG	ADDITIONAL DATA AND TEST RESULTS	SAMPLES TESTS
									EH	VH	H	M	J	VL	EL	EC	VC	W	WW				
20	-12.68				V	MICRODIORITE (Kgwu) HW: Grey, fine grained, very low strength.															30/120	SPT	
21					W		HW													18.27m-22.09m: Rock Roller bit used.	30/100	SPT	
22	-14.77				X	MICRODIORITE (Kgwu) SW: Grey, fine to medium grained, massive, very high strength. Defects: - Js; 0°-30° (3/m); Pl/Sm, TI-CD, some Cly; - Js; 30°-60° (3/m); Pl/Sm, TI-CD, some Cly; - Js; 60°-90° (1/m); Pl/Sm, TI-CD, some Cly;														22.25m-22.35m: Core Loss 22.45m-22.46m: Clay seam.	30/90	SPT	
23			(0) 71				SW													Is(50) = 1.02MPa; # A (22.85m) Is(50) = 1.46MPa; # D (22.90m)			
24			100 (10)				SW													Is(50) = 1.23MPa; # D (23.20m) Is(50) = 4.33MPa A (23.28m)

25			100 (70)				HW													23.80m-23.81m: Clay seam. 23.95m-24.25m: CS (5x); 10mm. 24.35m-24.55m: MW Granodiorite			
26							SW													24.85m-25.10m: HW zone, CA; Is(50) = 2.44MPa D (25.30m) Is(50) = 4.10MPa; # A (25.36m)

26.48	-19.16		100			Borehole terminated at 26.48m.														Is(50) = 7.39MPa D (26.45m)			
27																							
28																							
29																							
30
