BOREHOLE ENGINEERING LOG

HOLE NO : CURVE 22_BH10

CLIENT : TRANSPORT AND MAIN ROADS	POSITION : E: 359426, N: 8137537 (56 MGA94)	PAGE : 1 OF 2
PROJECT : BLACK SPOT PROJECT	SURFACE ELEVATION : 109.2 (AHD)	DATE DRILLED : 8/8/13 TO 8/8/13
JOB NO : CB24735.04	DIP / AZIMUTH : 90°	LOGGED BY : JP
LOCATION : KENNEDY HWY (CAIRNS - MAREEBA)		CHECKED BY : AJ

Client: Transport and Main Roads	
		Project: Black Spot	
drawn	AJ	Core Photograph – Curve 22_BH10	
date	14/08/2013	Project no. CB24735.04	Photo No: Curve 22_BH10
scale	NTS		1 of 1

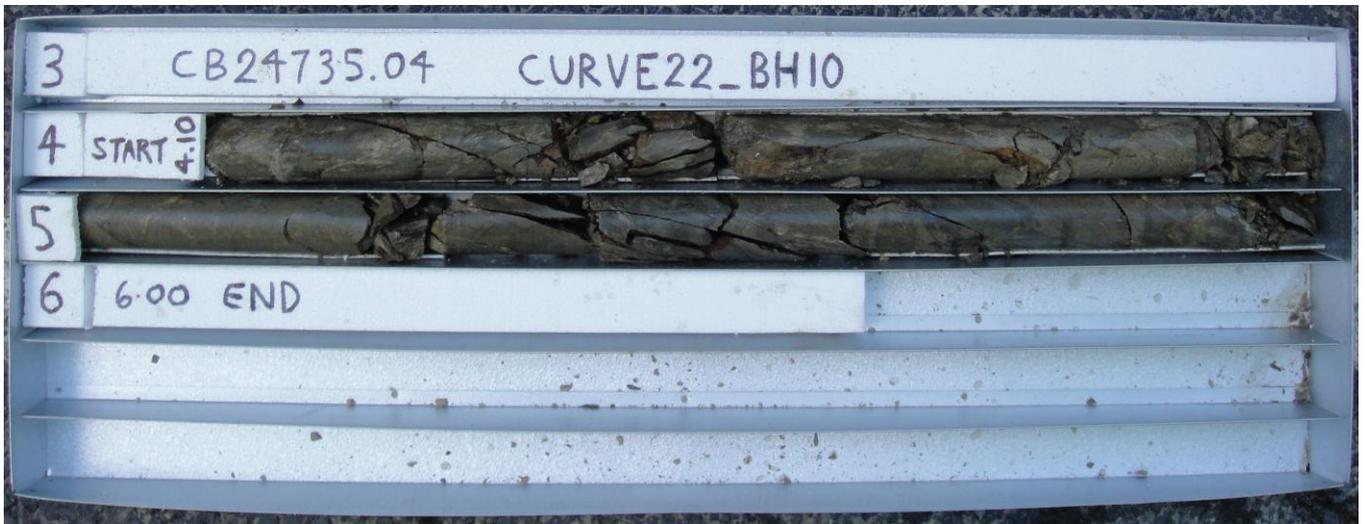
109.2	0.0							
			108.2	1.0							
			107.2	2.0							
			106.2	3.0							
			105.2	4.0		START CORING AT 4.10m					
						QUARTZITE: Grey, grey brown, indistinct to distinct bedding at 30° to 40°.	MW			4.10 JT 40° IR RF 4.20 JT 10° IR RF 4.26 JT 20° IR S 4.34 JT 5° IR S 4.37 JT 5 - 90° IR RF 4.82 JT 30° PR RF 5.20 JT 60° IR RF 5.50 JT 30° IR RF 5.60 JT 0 - 40° IR RF 5.82 JT 20° CU RF 5.95 JT 5° IR RF	JT 70 - 90 PR-IR RF
						Terminated Cored Drill Hole at 6.00 m
