**GEOTECHNICAL  
BOREHOLE LOG**

BOREHOLE No **BH05**

PROJECT Velway 1 Stage E: Birdwood to Gaza Road  
 LOCATION Bridge over Marshall Rd and Bapaume Rd. COORDINATES 505475.7 E; 6955355.1 N  
 PROJECT No FG6253 SURFACE RL 22.65m PLUNGE 90° DATE STARTED 03/06/2015 GRID DATUM MGA94 Zone 56  
 JOB No 201/C001/4 HEIGHT DATUM AHD BEARING ° DATE COMPLETED 03/06/2015 DRILLER Geodrill

**CORE PHOTO LOG**

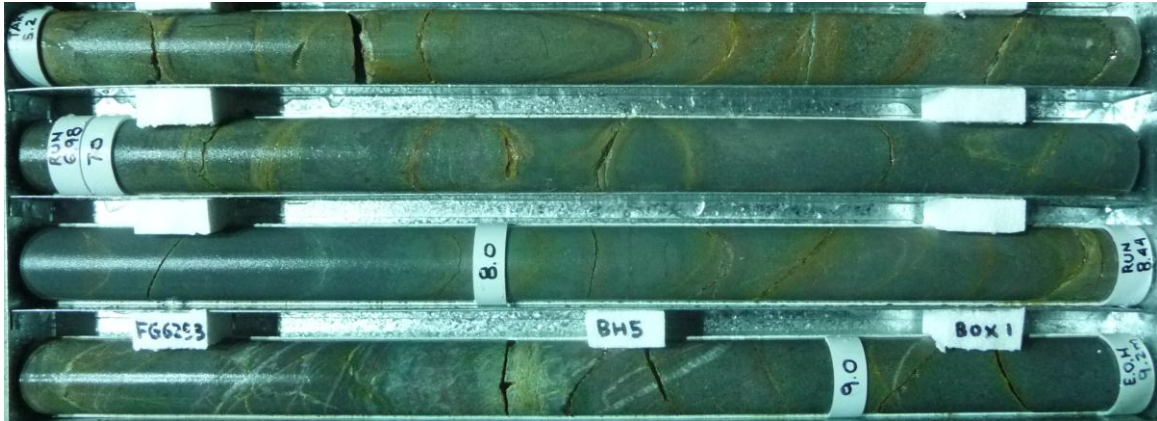
Project Name	<b>Veloway (V1), Section E: Birdwood to Gaza Road</b>		
Project No	FG6253	Date	3/6/15
Borehole No	BH 05	TMR H No	12194
Location	Bridge over Marshall Rd and Bapaume Rd	Start Depth (m)	5.2
Detail		Finish Depth (m)	9.2
Chainage		Submitted By	J. Lopez
Remarks

17.05				F	METAGREYWACKE (Dcf) XW: Recovered as brown grey, moist, very dense, Clayey SAND.	XW				30/100	SPT	
16.45			(14)		METAGREYWACKE (Dcf) SW: Brown grey, fine to medium grained, weakly foliated, generally high to very high strength. Defects: -J's: 0°-20° (2-3/m) Pl/Sm-Ro, TI, Cly Vr, FeSt -J's: 30°-50° (3-4/m) Pl/Sm-Ro, TI, Cly Vr, FeSt -J's: 70°-80° (<1/m) Pl/Ro-Sm, TI, Cly Vr, FeSt Frequent Qz Veinlets.	SW					D (6.32m) A (6.68m) D (7.44m) A (7.55m)	
100 (36)										Is(50)=1.10 MPa Is(50)=1.90 MPa		
100 (42)										Is(50)=4.30 MPa Is(50)=1.50 MPa
